# An Investigation into the causes of the Heap Leach Failure at Victoria Gold's Eagle Mine, Yukon

December 2024

Doc No.: 6408\_TR\_0\_Inv\_HLF\_Failure

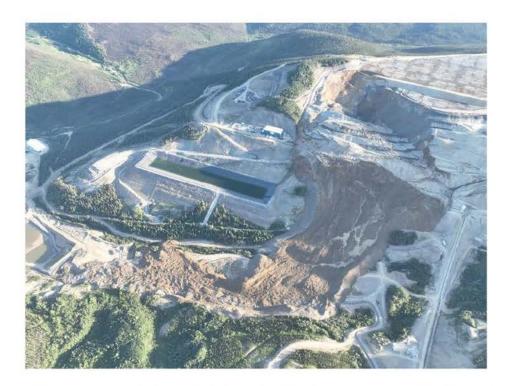
**Photograph 1:** Overview of the slide failure shortly after the event, taken from the south looking north (photo provided by YWSCB).

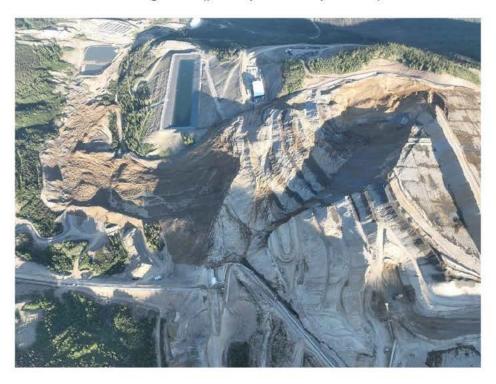
**Photograph 2:** Overview of the slide failure shortly after the event, taken from the east looking west (photo provided by YWSCB).

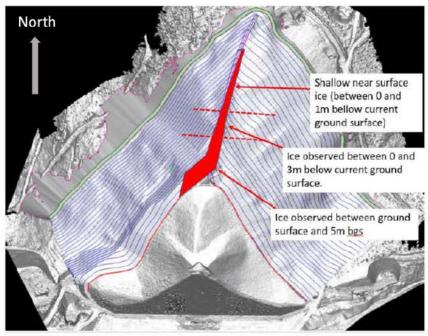
Figure 4: Plan of frozen ground from 23rd October dayshift report.

It should be noted that the location of the frozen ground is also where the under-drainage pipes were located and constructed. From the daily report of 3<sup>rd</sup> November, 2018, it was noted that over-liner drain fill (ODF) was frozen in some locations following placement on top of the liner. The temperatures on this day were -15°C to -23°C, yet the geomembrane LDPE liner was being placed. Based on a review of the membrane welding (seaming) records from Layfield, welding of the membrane in sub-zero temperatures was common practice and on one occasion 16 seam panels were welded in air temperatures of -25°C.

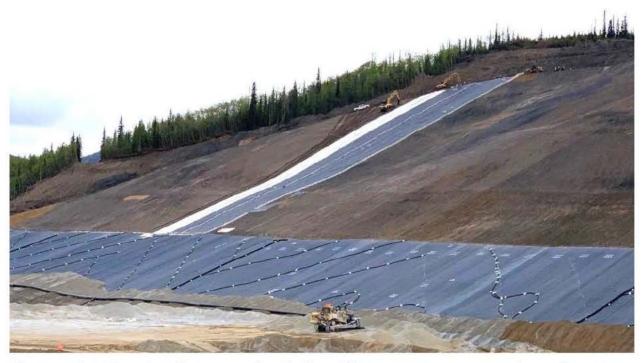
Photograph 4: Liner installation on subgrade from 4<sup>th</sup> June, 2019 on western slope, Phase 1B.

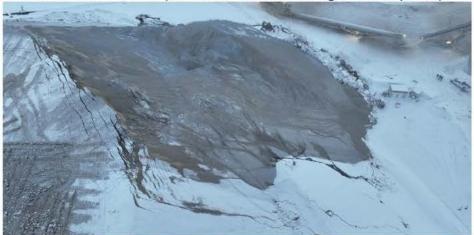
Photograph 5 below shows the slide (note truck for scale on right side of photo).

Photograph 5: Failure of the heap leach ore on 6th January, 2024.

It was perhaps initially considered that this failure was due to an ore slope constructed higher than the design i.e. 33 m height, not a 10 or 12 m lift. However, the observations during remediation and repair show that this was a failure that involved the side slope lining and the ore. It is regrettable that investigation of the cause of the failure was not carried out. Notwithstanding this comment, the fact that an over high ore slope was constructed should have been recognized at least 3 months prior to the failure.

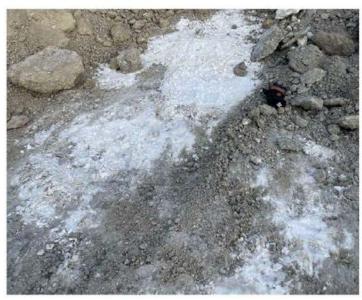
**Photograph 6:** From Forte's Daily Observation Report on 15<sup>th</sup> March; frozen ODF and ice (spelling error per original document)

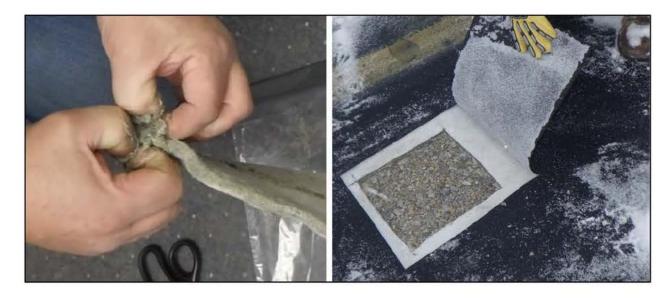
Photograph 7: Sampling of GCL not covered with ODF. Note hydration of bentonite in GCL core and frost on inside of geomembrane (photo provided by YWSCB).

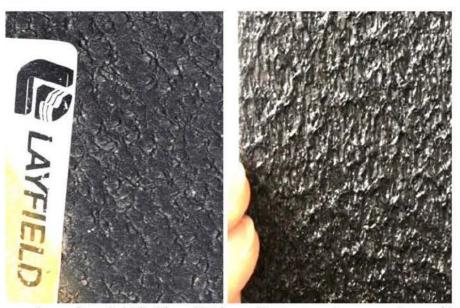
Figure 14: Comparison of Layfield (left) and high quality textured geomembrane (right)

Based on this comparison it appears that the textured geomembrane used on site was of a poorer quality than might have been the case.

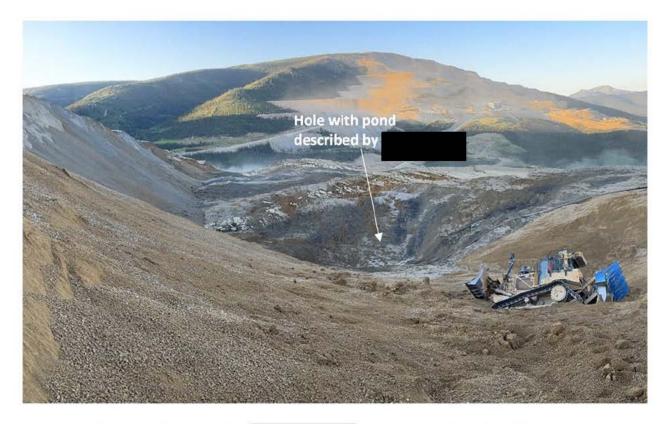
Photograph 8: Taken by immediately after the slide event.

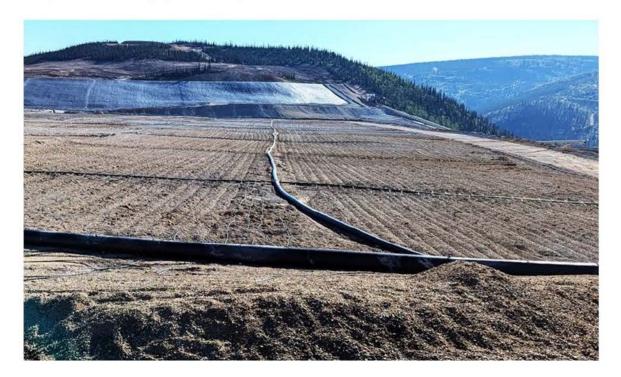
Barren solution drip lines on the 1065 level were reviewed. These show that only partial and shallow burial of the drip lines from the larger distribution pipes has been carried out (refer to Photograph 9 below).

Photograph 9: Distribution of the drip lines for barren solution on the 1065 level.

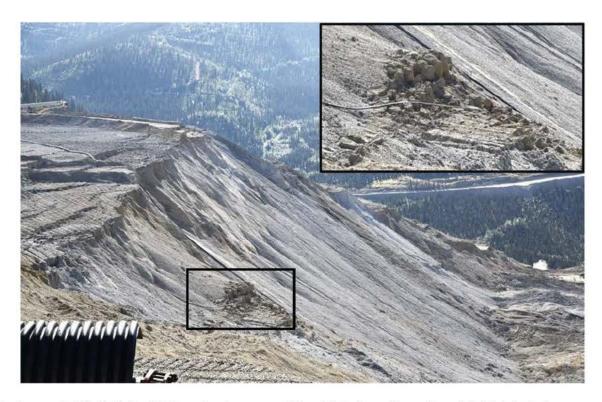
**Photograph 10:** Detail of failure backscarp, a 60 m high slope face. Area highlighted shows boulder sized 'blocks' or ore, considered to be more compacted sand from a remanent access road.

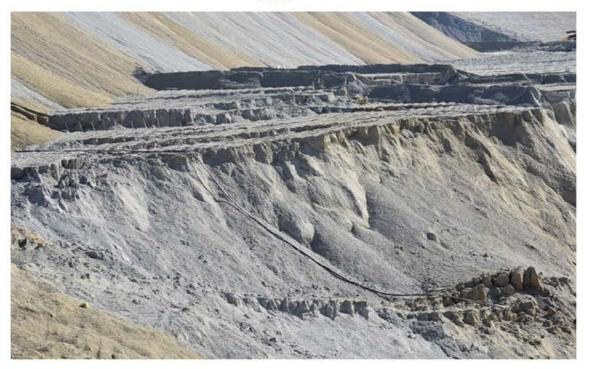
Photograph 11: Detail of failure backscarp and drip lines on the 1053 level.

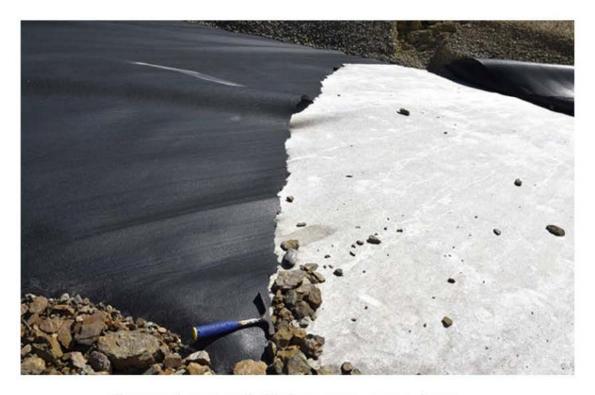
3) Photograph 12 shows a tear in the liner with movement between the 2mm textured LLDPE and the GCL. The slope at this location was measured at 1V:2H.

Photograph 12: Detail of failure tear in geomembrane.

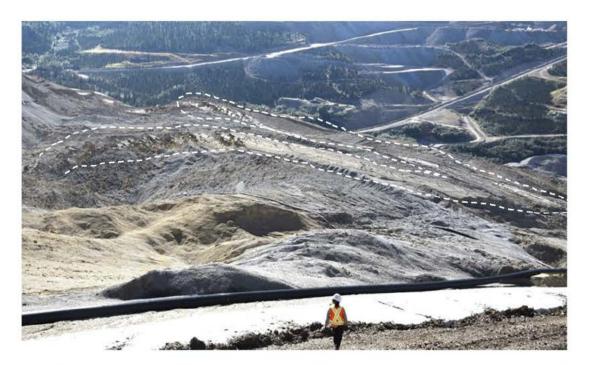
4) Photograph 13 shows the middle part of the slide, note a sinuous strip of more cohesive ore that in failing has formed 'blocks' of ground. This is thought to be the location of the access road up the heap leach face where compaction potentially led to a higher shear strength.

**Photograph 13:** Detail of middle part of failure and remanent of access road (white dashed line).

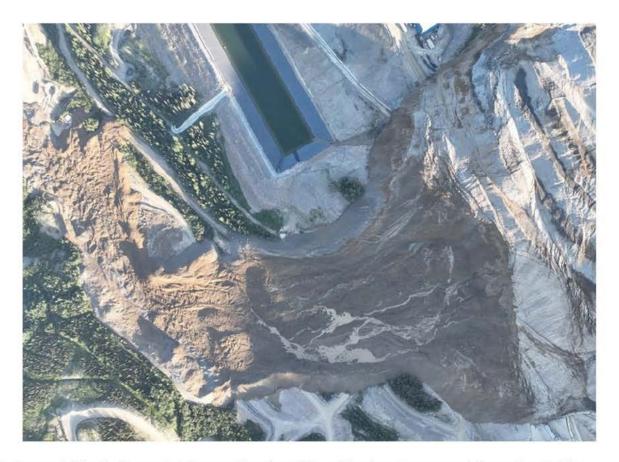
**Photograph 14:** Photograph taken on the day of the slide showing run out down the Dublin Gulch drainage.

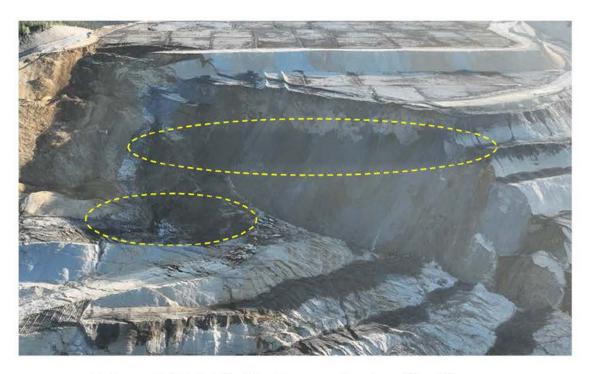
Photograph 15: Detail of backscarp on the day of the failure

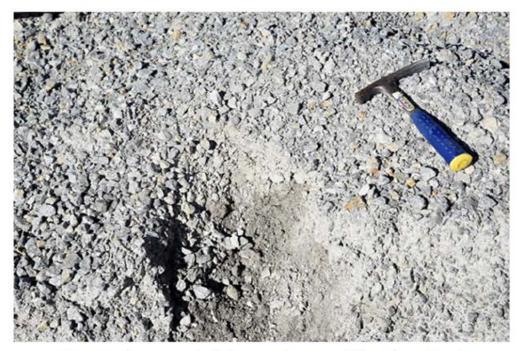
7) The observed ODF used on site appeared to have a high fines concentration. It is understood that this gravel is sourced from a nearby borrow pit. The ODF in this case does not appear to have been washed or screened. Refer to Photograph 16.

Photograph 16: Detail of the over-drainage fill (ODF) as placed.

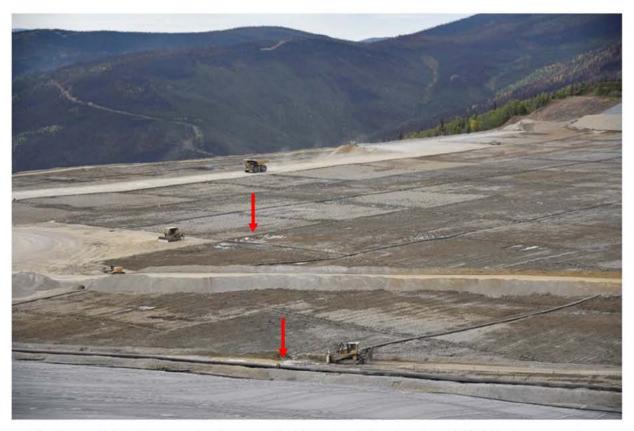
8) Photograph 17 from September 2023 shows ore placement in the final part of the 1053 level. Note minor ponds of barren leachate across the HLF pad and location of haul road.

**Photograph 17:** Placement of ore on the 1053 level (September 2023). Red arrows show ponding.

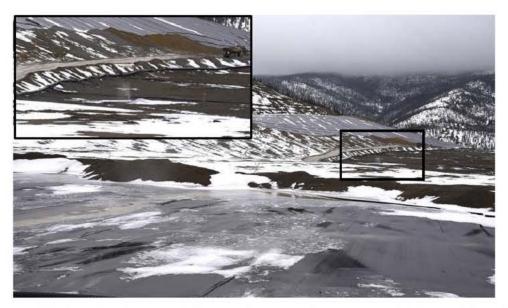
9) Photograph 18 shows the heap leach pad in October 2022 (ore placement at 1041 level). Note ice on geomembrane, and ponding around junction with ODF. In background spray from a leak in the barren distribution system can be observed. The haul road appears 'muddy'.

**Photograph 18:** Heap leach pad in October 2022 (ore placement at 1041 level). Insert shows 'blow out' of barren distribution line.

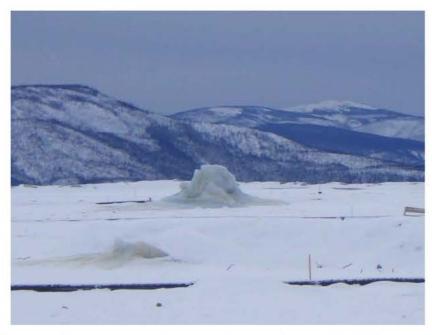
10) A site visit was made by YWSCB following the failure on 26<sup>th</sup> October, 2024. Photograph 19 shows one of several locations where frozen brine was spilling and freezing. This photo was taken when the temperature on site was reported as -12°C. Testimony recorded by YWSCB from the site operators indicates this was a common occurrence throughout the winter. We therefore contend that ice lenses were formed within the HLF during winter stockpiling.

Photograph 19: Ice formation from brine leak on 26th October, 2024.

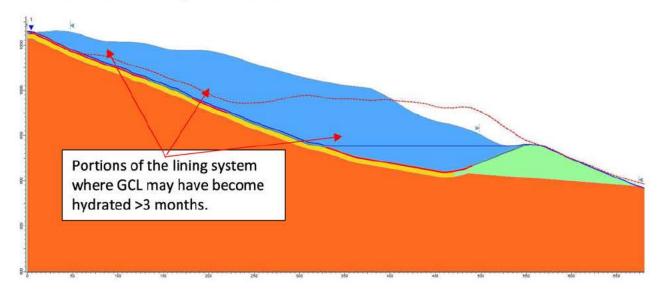
A FoS of 1.03 resulted, indicating that the HLF would be marginally stable if all of the GCL along these exposed sections were hydrated. It was concluded that hydration in the GCL could be one of the factors contributing to the failure.

Figure 30: Portions of the lining system exposed for >3 months along Section 1A
