Loader Accident Injures Worker

Placer Mining Industry

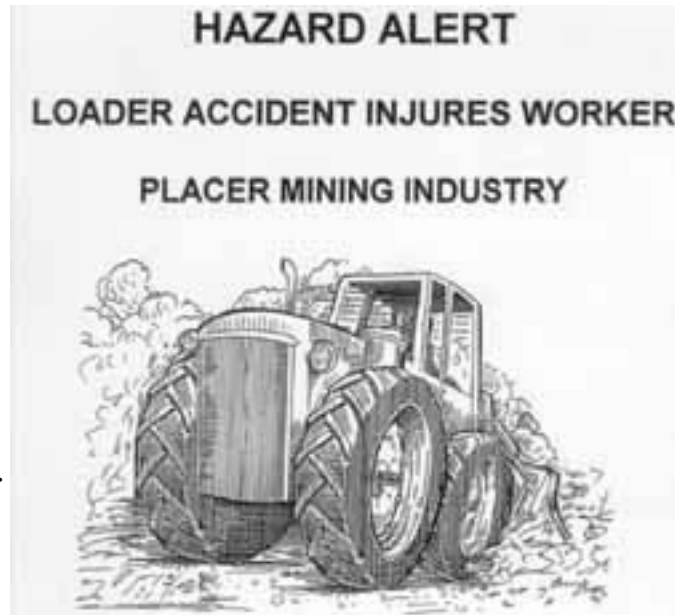
A loader operator received head and neck injuries while operating a loader without using the seatbelt.

The loader brakes failed so the operator dropped the bucket to stop the loader. The bucket dug in and stopped the loader suddenly. The operator hit his head on the windshield.

The accident resulted from faulty brakes on the loader. The injury resulted because the operator was not wearing the supplied seat belt.

The *Occupational Health and Safety Act* 3(1)(2) requires that the employer ensures that machinery and equipment are in safe condition.

The General Safety Regulations section 70(1) requires that mobile equipment be equipped with seat belts and that operators use them.
