# An Investigation into the causes of the Heap Leach Failure at Victoria Gold's Eagle Mine, Yukon

December 2024

Doc No.: 6408\_TR\_0\_Inv\_HLF\_Failure

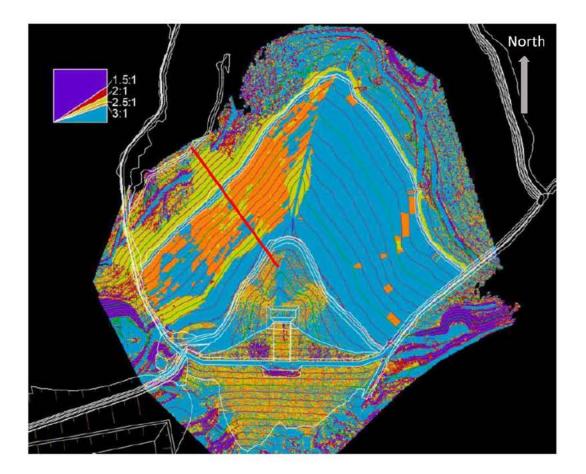
Figure 5: As built gradients of the lining system (taken from Figure 4 in Appendix 7 of (BGC, 2019)). Red line depicts steepest gradient.

The figure shows that the side slope and liner to the north-west above the in-heap containment pond was constructed at an angle of between 1V:2.5H (22.5°) to 1V:2H (26.5°). The red line on this figure depicts this steepest angle. Under Appendix B of the same report by Tetra Tech (2019), an email conversation between BGC and Tetra Tech showed the approval of liner installation on the aforementioned steep slopes.

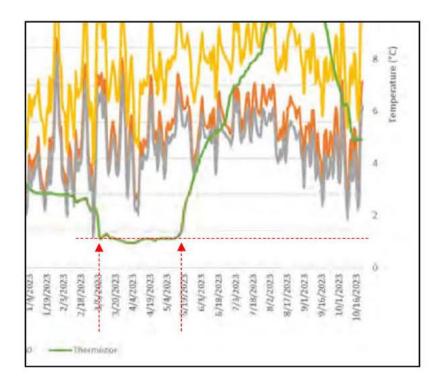
In March 2024 the annual report for 2023 was published by Victoria Gold (Victoria Gold, 2024). This report presents temperature data from two piezometers (P2 and P3) located above the heap leach in-pond containment. To October 2023 there was a general downward trend in the temperature of leachate to just below 4 °C. Data is presented from a thermistor within the ODF (Phase 1B Horizontal ODF Piezometer levels), this shows that between March and May 2023 the temperature was around 1 °C. Figure 6 is taken from the 2023 annual report that presents the thermistor data, arrows have been added for emphasis.

Figure 6: Thermistor Data from Phase 1B Horizontal ODF Piezometer levels

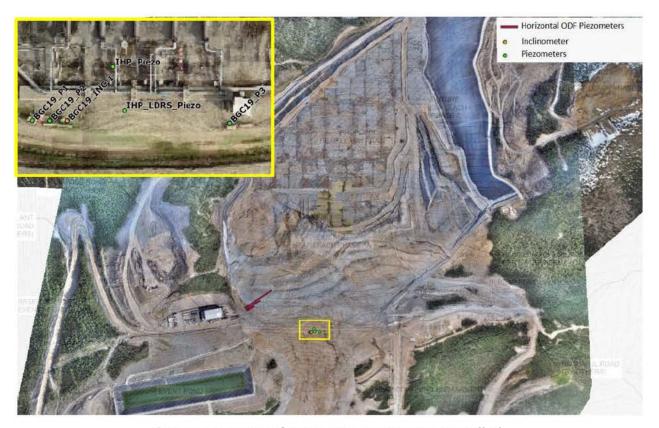
A layout plan of all monitoring instruments (inclinometers and piezometers) is shown on Figure 7. It is understood each piezometer was paired with a thermistor. It should be appreciated from Figure 7 that the vast majority of the heap leach was uninstrumented.

Figure 7: Location of Monitoring Instruments Installed

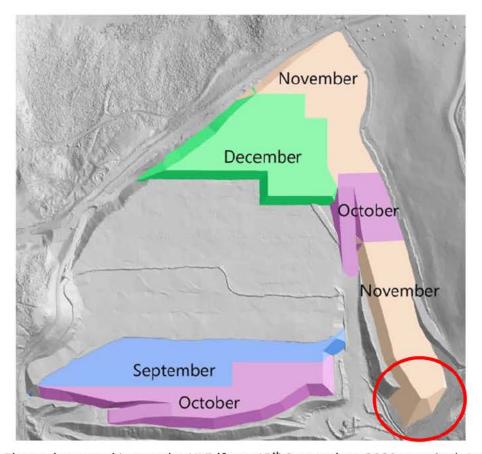
**Figure 8:** Planned ore stacking on the HLF (from 15<sup>th</sup> September, 2023 meeting). Location of failure highlighted.

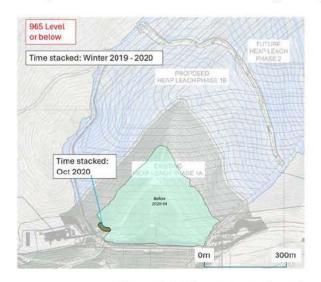
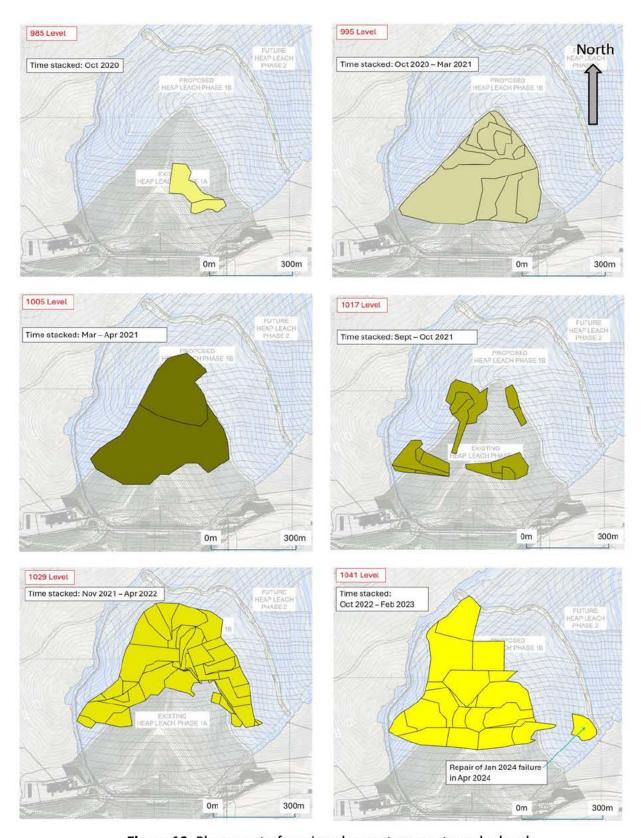
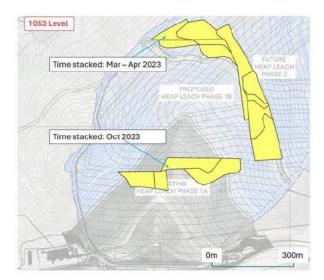
Figure 10: Placement of ore in sub-zero temperatures by level

It should be apparent from Figure 10Figure 10 that a substantial part of the western side of the Phase 1A and Phase 1B heap leach pad was placed in sub-zero temperatures particularly the 24 m thickness between 985 and 1005 & 1017 and 1041. Based on this analysis Delve Underground contend that parts of the ore remained frozen, even though barren solution was being irrigated on surface.

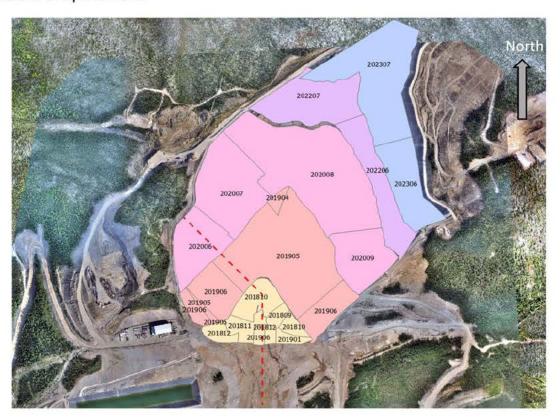
Figure 11: Timing of geomembrane completion and installation locations shown (highlighted dashed line is Section 1A).

From this review, it appears that large parts of the geomembrane were left exposed for a prolonged period before ODF was placed. As such, the time lag between ODF placement and geomembrane installation was then assessed along Section 1A, a critical composite cross section encompassing the steepest side slope of the HLF and the in-heap pond. The time lag between geomembrane and ODF placement along this critical section is summarized in Table 3 below.

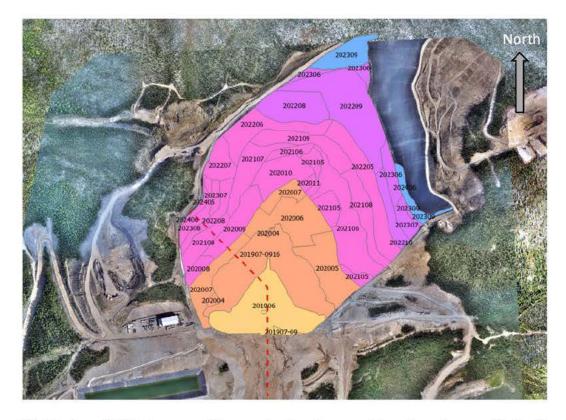
Figure 12: Timing of ODF placement (approximate placement location shown with Section 1A).

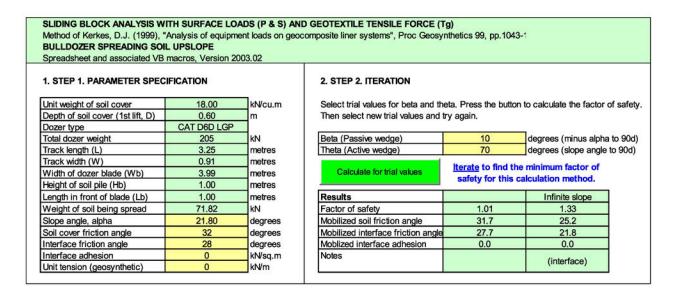
An analysis was undertaken using the formula by Kerkes (1999) to assess placement of the 0.6 m ODF layer on the geomembrane using a D6 Bulldozer and based on the liner gradients shown in Figure 5. This showed that the factor of safety against tensional failure was marginal (1.01) at a slope inclination of 1V:2.5H (refer to Figure 13) and if on the steeper slopes (1V:2H) the factor of safety is calculated to be 0.9 i.e. tensional failure of the geomembrane is indicated.

Figure 13: Factor of Safety Against Tensional Failure of LLDPE (Kerkes, 1999)

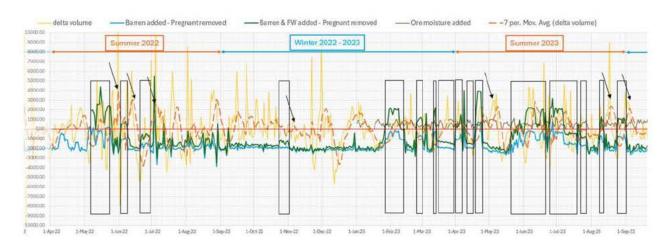
The graph below (Figure 15) shows the daily change in in-heap pond volume as a yellow line. The orange line shows this in-heap pond volume normalized to a 7-day moving average. The blue line shows the flow of barren solution minus the flow of pregnant solution from the HDR. One might expect these to balance out, but due to precipitation the flow to the in-heap pond and thence to the pregnant solution pumped out will be higher. As a consequence, there is a deficit averaging around 2000 m³ per day. On the basis that the area of the HLF was around 300,000 m², this deficit equates to 6 to 7 mm of precipitation per day, however over a year this is 4 times the rainfall that actually occurs. Only around 500 m³ of this deficit can be accounted for by precipitation. Another contributing factor is the moisture of the ore placed and this contributing to the volume seen in the in-heap pond. The moisture of the ore equates to around 470 m³. In summary there is still about 1000 m³/day of liquid coming into the system from either an unknown source (for example from a breach in the liner) or from an equipment (pump) error or mis-calibration of an instrument. From a review of the UMV flow data and the quantity of water, we believe the latter hypothesis (instrument error) is more probable than a liner breach.

Figure 15: Analysis of the HLF Water Balance Prior to Failure.

Figure 15 also shows when water was added to the HLF system as a green line. The black boxes in Figure 15 show when significant water was added to the heap leach system (green lines on graph). Following these water additions an increase in the in-heap pond can be seen some 2 to 3 weeks after the addition. In other words, it takes 2 to 3 weeks for the water added to make its way through the heap leach to the in-heap pond. Based on this time interval and considering the average thickness of the ore, one is able to calculate a global average hydraulic conductivity in the unsaturated condition as  $3.4 \times 10^{-5}$  m/s.

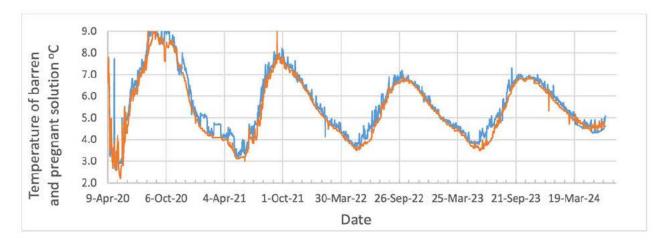
Figure 16: Temperature vs time of Pregnant (Blue) vs Barren (orange) solutions at ADR Plant

From Figure 16 it can be seen that in May of 2021, 2022 and 2023 there is a greater difference in temperature difference. This is thought to be caused by the lower temperature of the makeup water from the control and event ponds following winter. The difference reduces over the course of 2 months, this 'lag' is considered to be due to the water in the ponds slowly 'warming up' following winter.

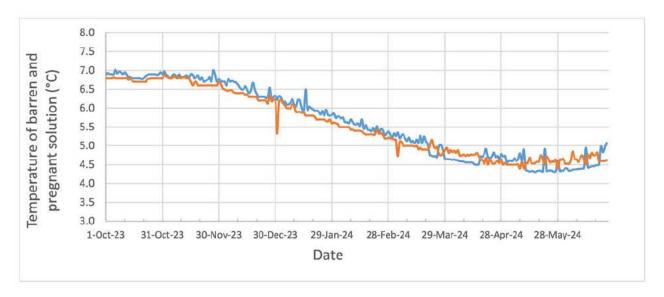
Figure 17: Temperature vs time of Pregnant (Blue) vs Barren (orange) solutions at ADR Plant

The inversion first occurs around 20<sup>th</sup> March, around 15<sup>th</sup> April the trend goes back to 'normal' but reverts again on 12<sup>th</sup> May. Based on a review of the Heap Leach weekly presentations it is noted that between week ending 17<sup>th</sup> May and 21<sup>st</sup> June that some 50,0000 cubic metres of water was added to the Heap Leach from (we presume) from the event pond and control pond,

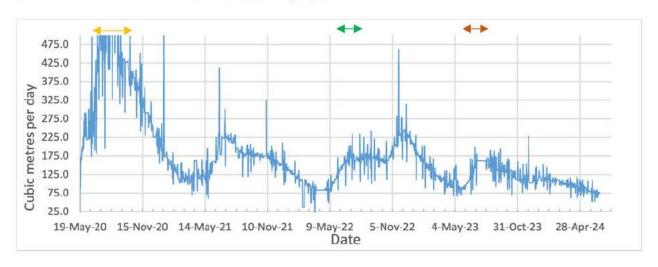
**Figure 18:** UMV drainage in m<sup>3</sup>/day. Arrows indicate construction of the geomembrane liner. Yellow: Phase 1B; June to September 2020. Green: Phase 2A; June & July 2022; Brown: Phase 2B; June & July 2023.

The data shows that there is a cyclic nature to the drainage under the HLF. During winter the flow is supressed and reduces to a base-flow in April and May. During the summer the flow

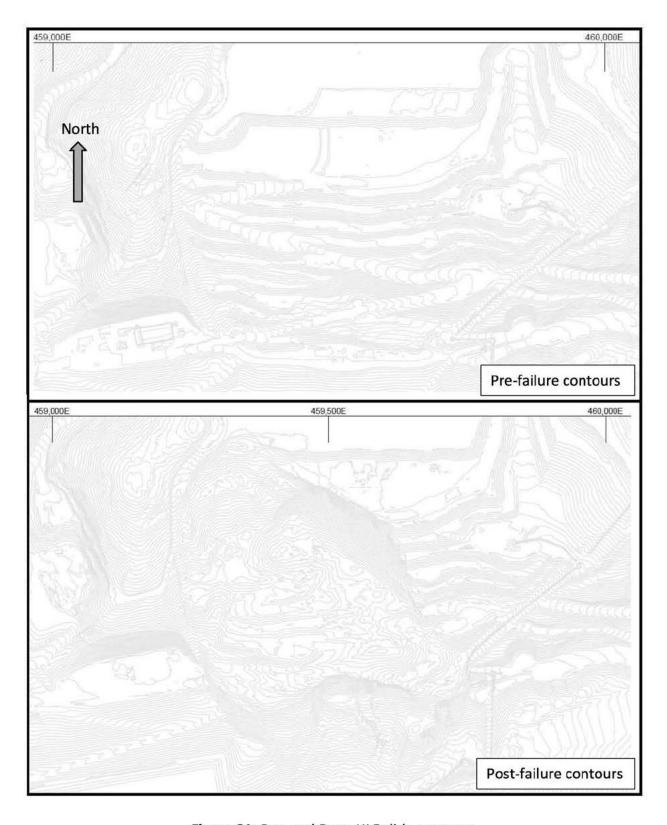
A review was undertaken of the pre- and post-failure topography of the slide, Figure 21 presents this comparison. This figure shows that the slide propagated back as far north as the 1065.5 level. The backscarp can be seen to trend from the central part of the HLF across the 1053 level towards the north-west. The eastern half of the HLF is relatively intact with little sign of movement. The access road that ran up the HLF face cannot be seen on the contours (although as noted the remnants of the access road can be seen on site as shown in Photograph 13). The 60 m high main backscarp face trends towards a bearing of 210 degrees (from North), the upper 30 m at an average inclination of 45 degrees. The overall direction of movement appears to be in a south-easterly direction, essentially in the same direction as the underlying sub-grade and liner installation (refer to Figure 21). Whereas the base of the failure just above the containment dam has moved directly south, and as noted in Photograph 1 trended around to the west towards the Control Pond.

Figure 21: Pre- and Post- HLF slide contours.

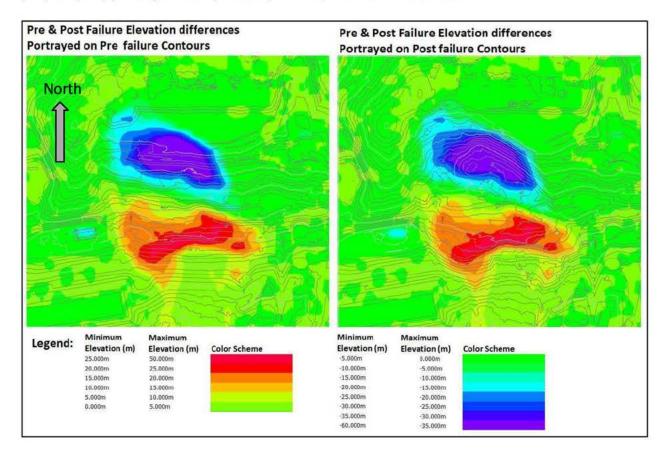
Figure 22: Isopachyte contours portrayed on pre- and post-failure contours

Figure 22 shows a displaced slide mass moving in volume from the north and backscarp towards the south-southeast. There is also movement towards the southeast as the red contour showing maximum thickening from the failure is aligned at an east-northeast to west-southwest direction and elongated towards the east. It is apparent from these contours that the failure was complex and in more than one stage following the initiating event. These observations have been interpreted later within this report to help define the failure mechanism.

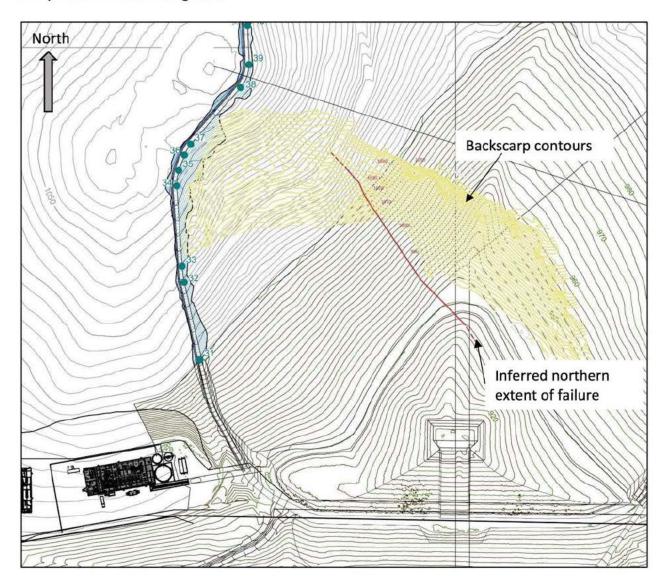
Figure 23 below presents this assessment, with an overlay of the backscarp contours (yellow) on top of the as-built sub-grade plan. This assessment shows the approximate northern extent of the slide surface and by implication that the main slide mass and movement was down the steepest area of the sub-grade.

**Figure 23**: Overlay of backscarp contours onto underlying sub-grade to show northern extent of slide movement.

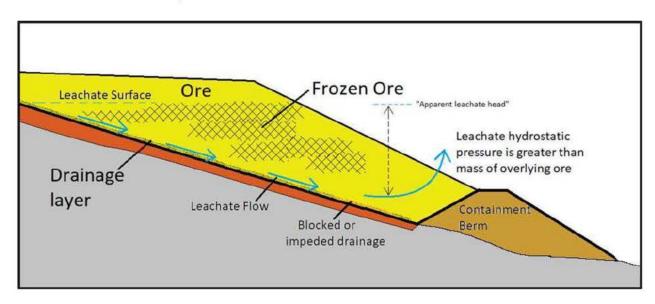
condition may have created perched leachate tables above the frozen ground that drain down the ODF towards the base of the HLF. On the basis that the drainage pipe system may have buckled (at the lower elevations where surcharge mass is highest) this may have led to high pore pressures in the ore at the base of the HLF creating an uplift hydrostatic pressure below frozen layers at depth and potential failure. Figure 25 below attempts to graphically display this mode of failure, which the authors acknowledge is somewhat unique. Assessment is

**Figure 25:** Sketch of Mode 3C – Failure of the ore due to hydrostatic uplift pressures.

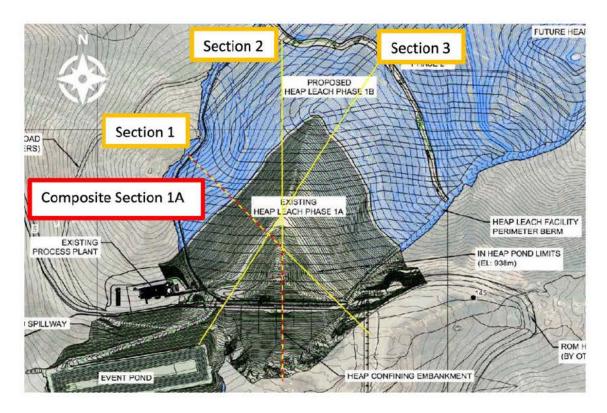
Figure 26: Sections overlaid on HLF layout plan.

Figure 26 shows an overlay of the location of the three sections on a layout plan (extracted from drawing 109005-51100-03 GA-F003 included in Detail Design Report for Eagle HLF Phase 1B (Forte, 2020)) showing the contours of the lining system before ore placement. Figure 26 shows the location of the sections overlaid on post-failure orthophoto taken on 26<sup>th</sup> June. It should be noted that Section 1 aligns parallel with the inferred sliding surface along the steepest gradient of the liner slope shown on Figure 5.

Section 1 was selected within the failed slope where the lining system was the steepest on the west side of the HLF. Section 2 was selected through the center of the embankment dam. Section 3 was selected where the lining system was the steepest on the east side of the HLF, perpendicular to the exposed upper head scarp, extending to the slope adjacent to the Event Pond.

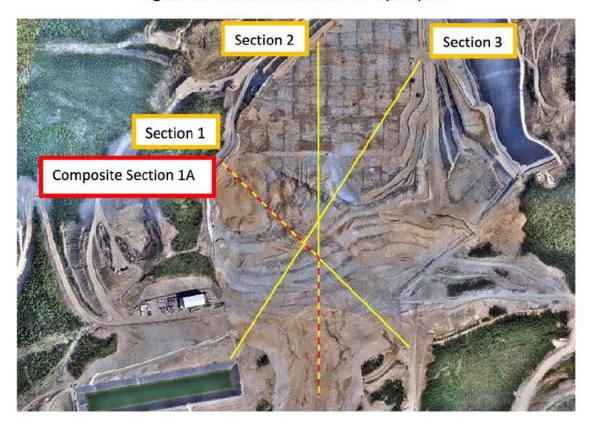
Figure 27: Sections overlaid on post-failure site orthophoto on 26<sup>th</sup> June

It is recognized that the stability of the HLF may be governed by a 3-dimensional aspect, for this reason a composite section 1A was introduced into the modelling as set out on Figure 27 above. This composite section 1A follows the steepest section of the side slope lining and subgrade, but also follows part of Section 2 with the steepest outer slope face of the HLF.

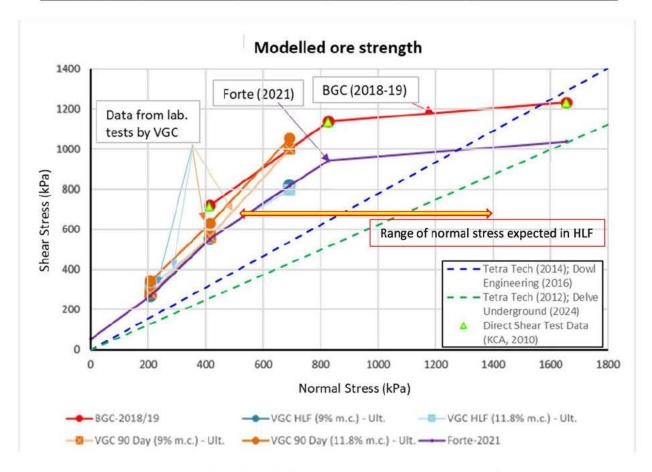
Figure 28: Plot of modelled ore strength in previous analyses

In the absence of laboratory testing, the crushed ore was modelled as cohesionless with a friction angle of 32 degrees in Tetra Tech's analysis for the choice of embankment materials in 2012 (Tetra Tech 2012). Following this assessment when laboratory testing data by Kappes, Cassiday & Associates (KCA) became available, an increased friction angle was used by Tetra Tech in 2014. Subsequent analysis by BGC (2018) adopted the testing data directly as a shearnormal function, which significantly increased the strength of the ore in the model. Further testing was carried out by Victoria Gold Corp. (VGC) with 9 and 11% water content in the ore. Forte (2021) then adopted an updated shear-normal function for ore strength. At normal stress range below 691 kPa, the lowest among the tests by KCA and VGC (at 9% water content) was used, and at normal stress range above 691 kPa, a shear-normal function parallel to and lower than the function proposed by BGC was used (see Figure 28 below).

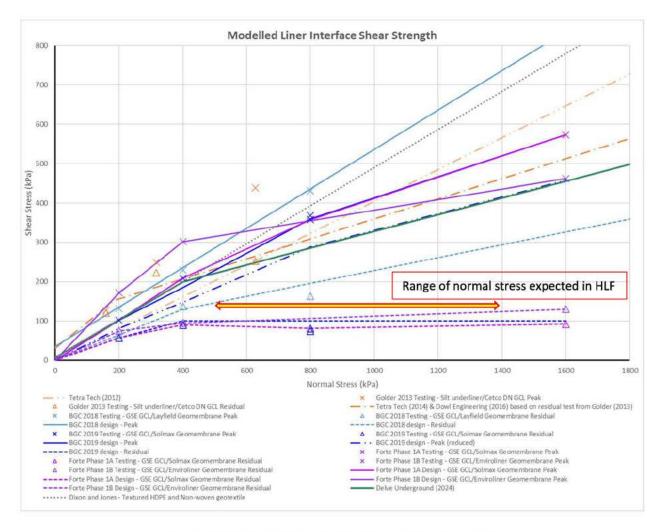
Figure 29: Modelled Liner Interface Shear Strength

In reviewing all laboratory testing data, the shear strength between non-woven geotextile and geomembrane suggested by Dixon and Jones (2003) appeared to be applicable at low normal stress below 400 kPa. A bilinear strength envelope with friction angle of 12 degrees for normal stress higher than 400 kPa was considered conservative based on the tested peak strengths. Although it was observed in the 2019 BGC testing that GCL failed in addition to the GCL to geomembrane interface, it was unsure whether the low internal shear strength of bentonite within the GCL, as reported in the conformance tests, would be mobilized. Nevertheless, it was considered shearing of the GCL to geomembrane interface would occur prior to the rupture of the GCL and subsequently shearing of the bentonite within the GCL. Thus, a friction angle of 12 degrees was considered above a normal stress of 400 kPa. Details of liner interface used in each analysis was summarised in Table 9 and plotted on Figure 29 below. Brands of interface material tested and used for construction was also compared in Table 10 and Table 11. It was noted that none of the combinations tested reflected what was installed on site (i.e., a Layfield manufactured 2 mm thick LLDPE geomembrane to a Solmax manufactured GCL).

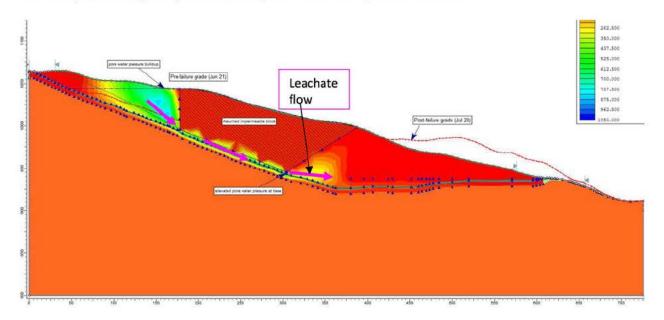
Figure 35: Example model setup for Failure Mode 3C in Section 1

impermeable block was assumed mid-slope (using grid points with 0 pressure head). Build-up of pore pressure was modelled by arrays of pore pressure grid points up-gradient of the impermeable block. It was then assumed that such build-up of pore pressure remained constant between the impermeable block and the lining system, until the pore pressure was released downslope in the ore. Such a pore pressure regime was illustrated in Section 4.3 and an example of the pore pressure setup is shown in Figure 35 below.

Sections 1A, 1 and 2 were first analyzed with an assumed 70 m pore pressure build-up. It was observed that marginal stability (FoS  $\approx$  1) was achieved at Section 1A. The pore pressure build-up at Section 1 & 2 were then increased to assess what pore pressure build-up would be needed for the section to achieve marginal stability. Results are summarised in Table 17 below.

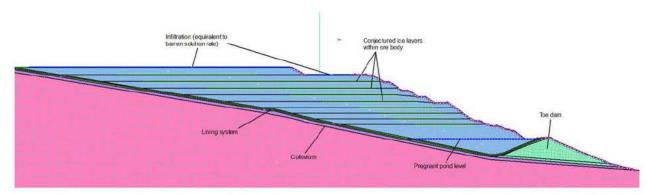
Figure 36: Seepage model with conjectured frozen layers within the ore, Section 2

Figure 36 presents the illustrative seepage model that includes the following elements (adopted hydraulic conductivity values, k, are presented for each element):

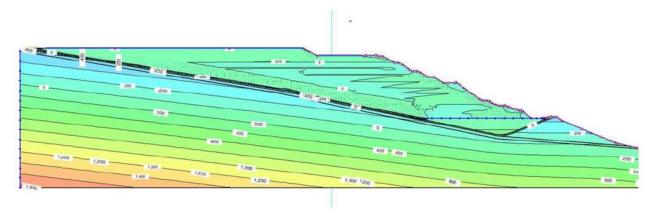
Figure 37: Pore water pressure contours from illustrative seepage analysis, Section 2

For the purposes of the illustrative analyses, a simplistic steady state, as opposed to transient, seepage model was adopted. Figure presents the pore water pressure contours and confirms:

- The derivation of a complex pore water pressure regime with perching on ice layers.
- The development of a zone of high pressure at the rear of the lining system, with the highest pressures being present towards the top of the slope.

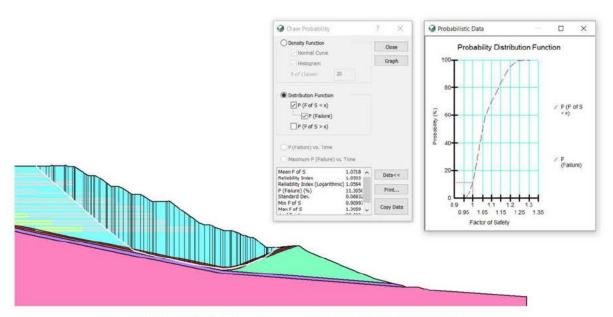
Figure 38: Critical slip surface and probability distribution function

Based upon the foregoing ranges in values, the probability of failure of the structure was determined to be 11.3% - i.e. there was a greater than 1 in 10 probability that failure would occur. Figure 38 provides a summary of the probabilistic analysis results.

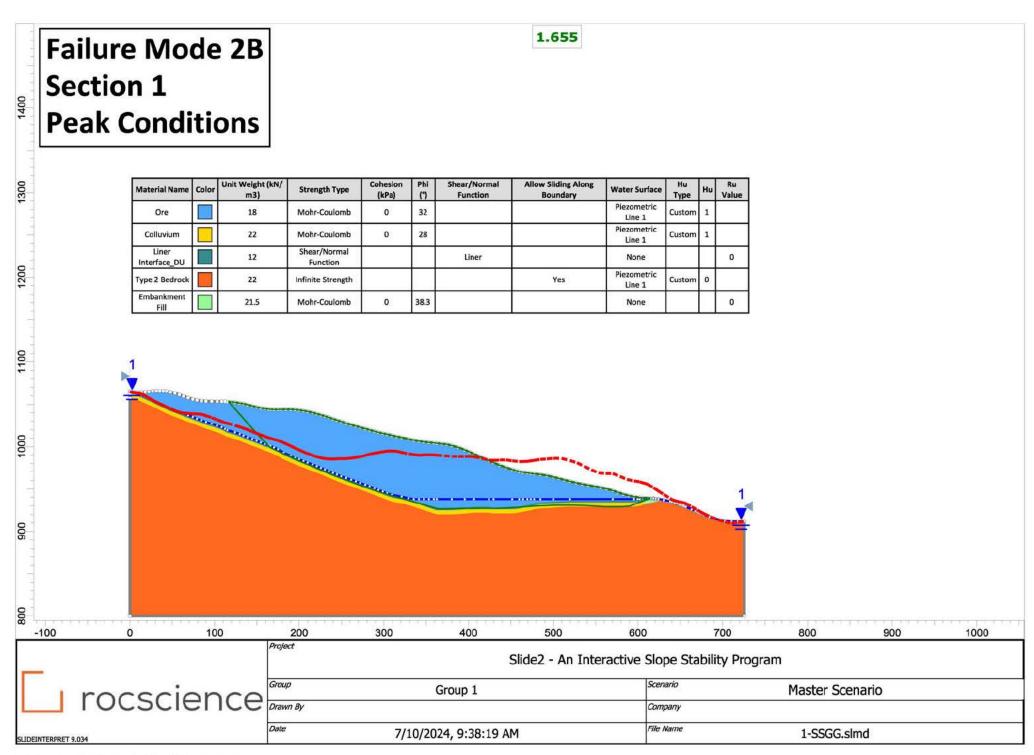
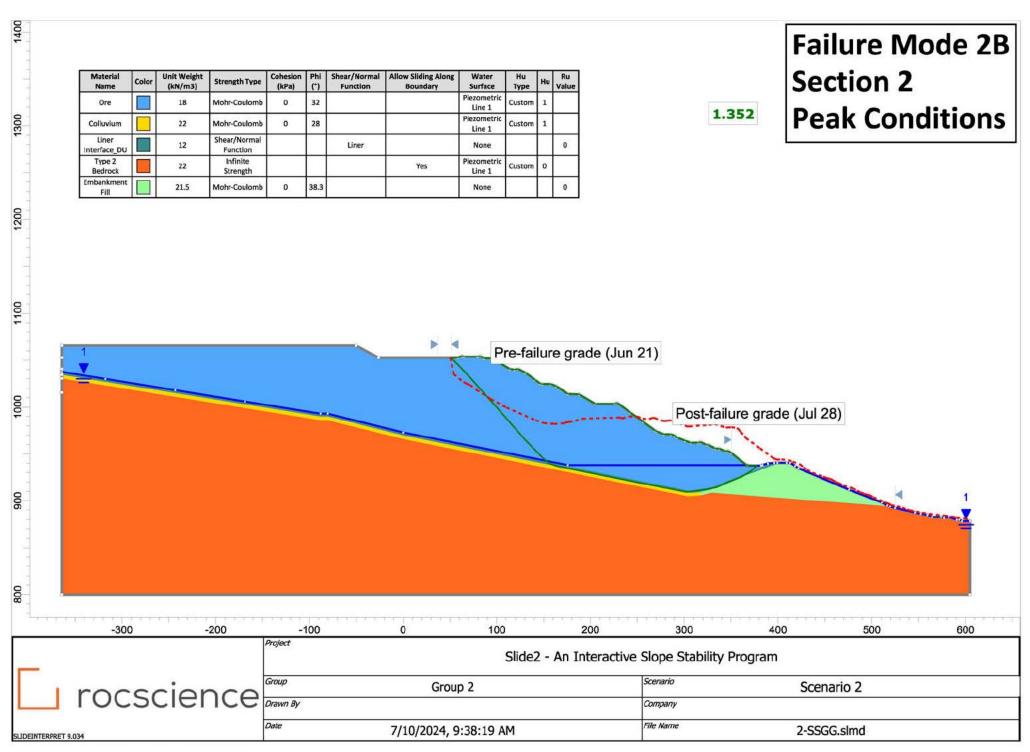
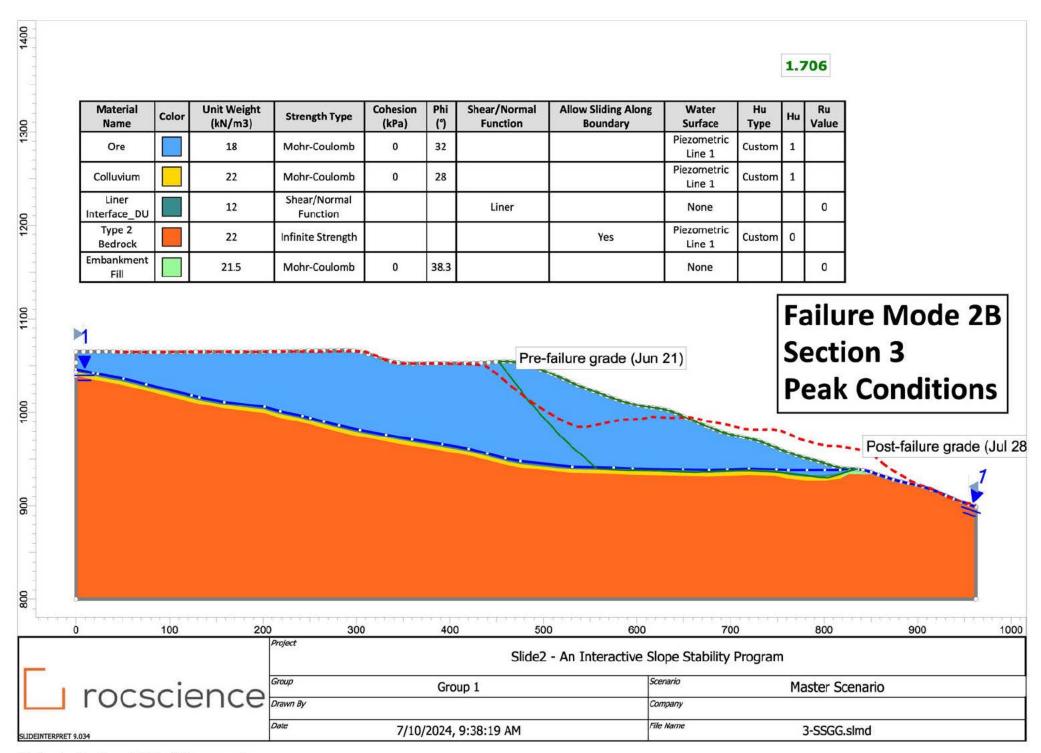
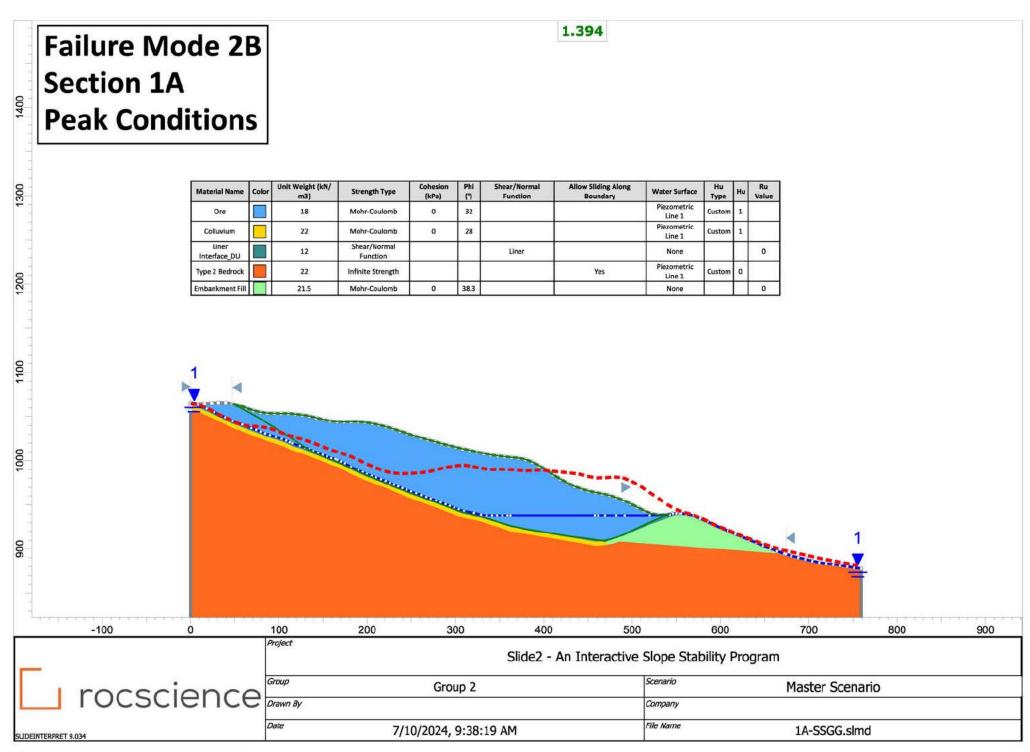
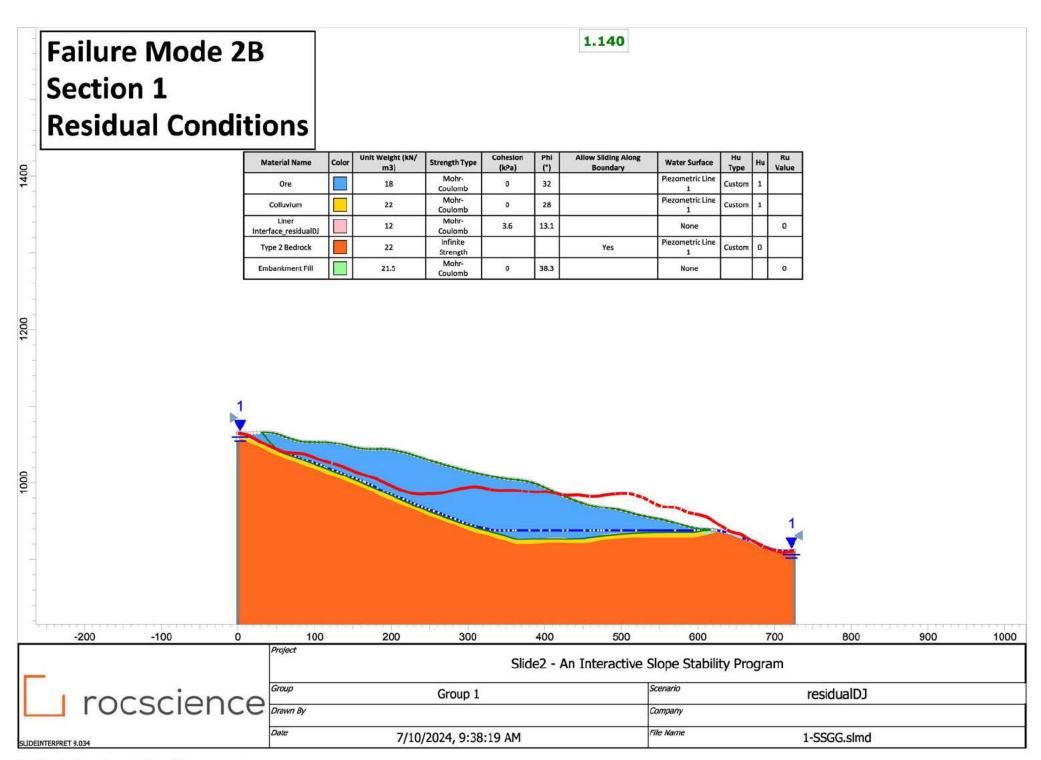
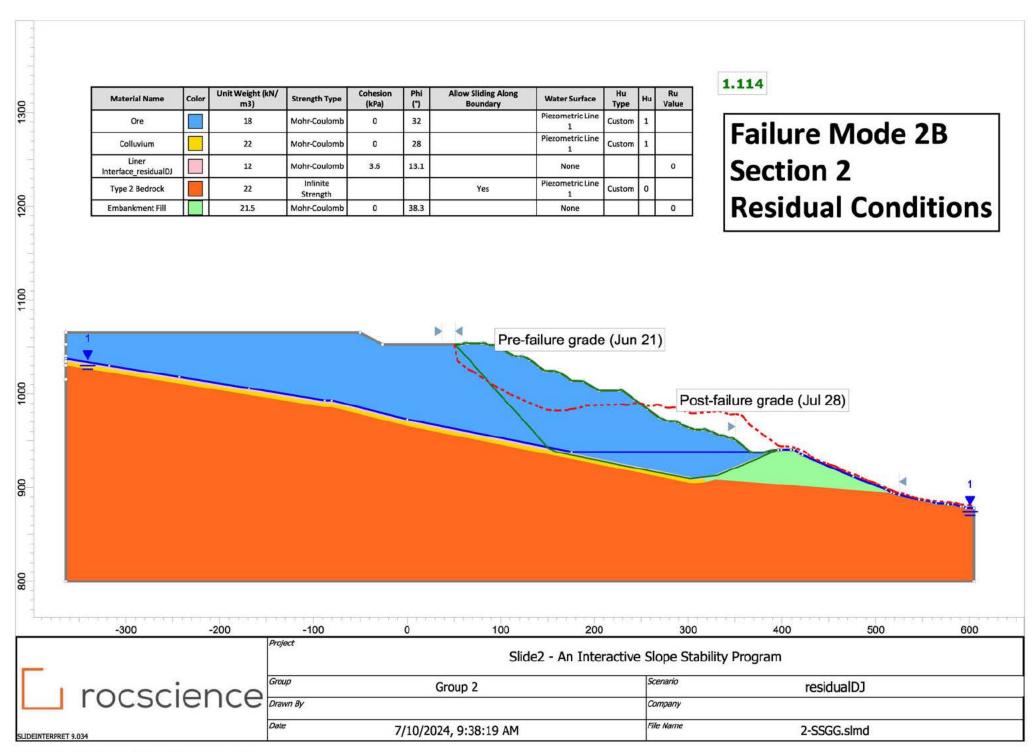
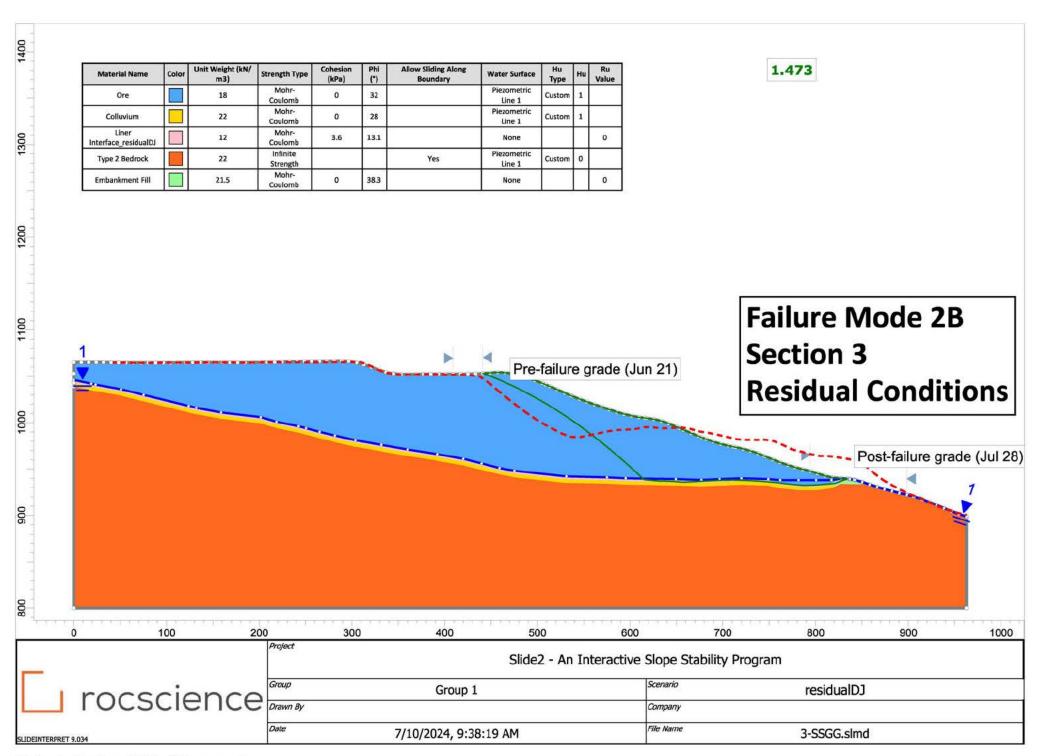
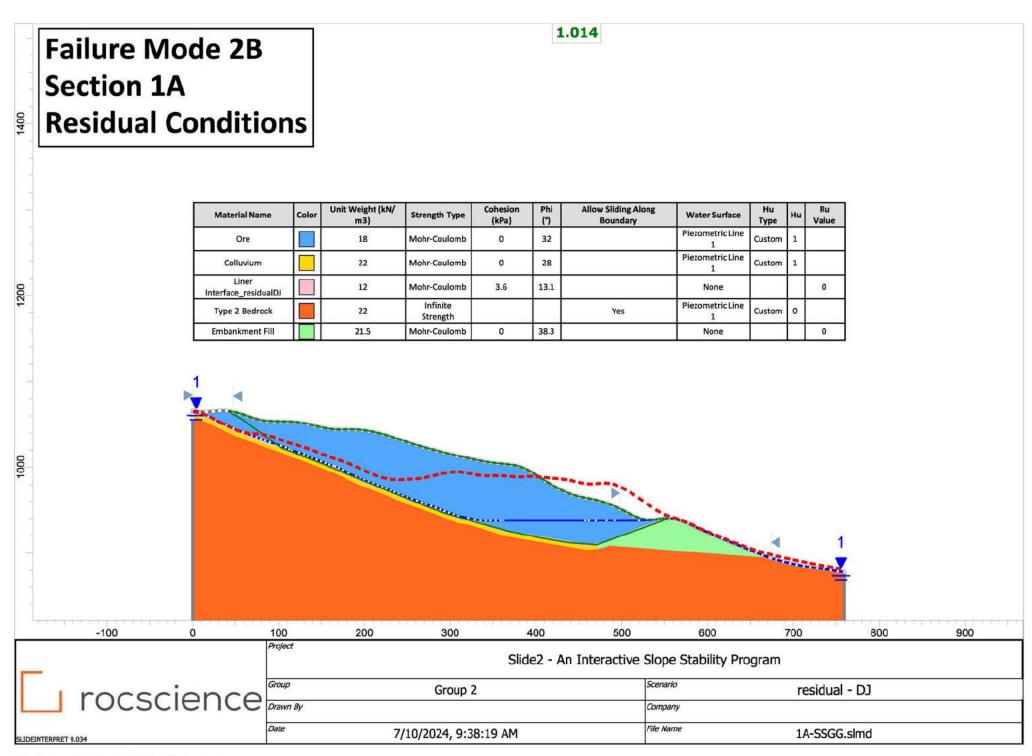
# Failure Mode 2B Lining failure along the interface between LLDPE Geomembrane and GCL

Failure Mode \ Section	1	2	3	1A
Mode 2B – Lining failure along the interface between LLDPE Geomembrane and GCL	Y	Υ	Υ	Υ

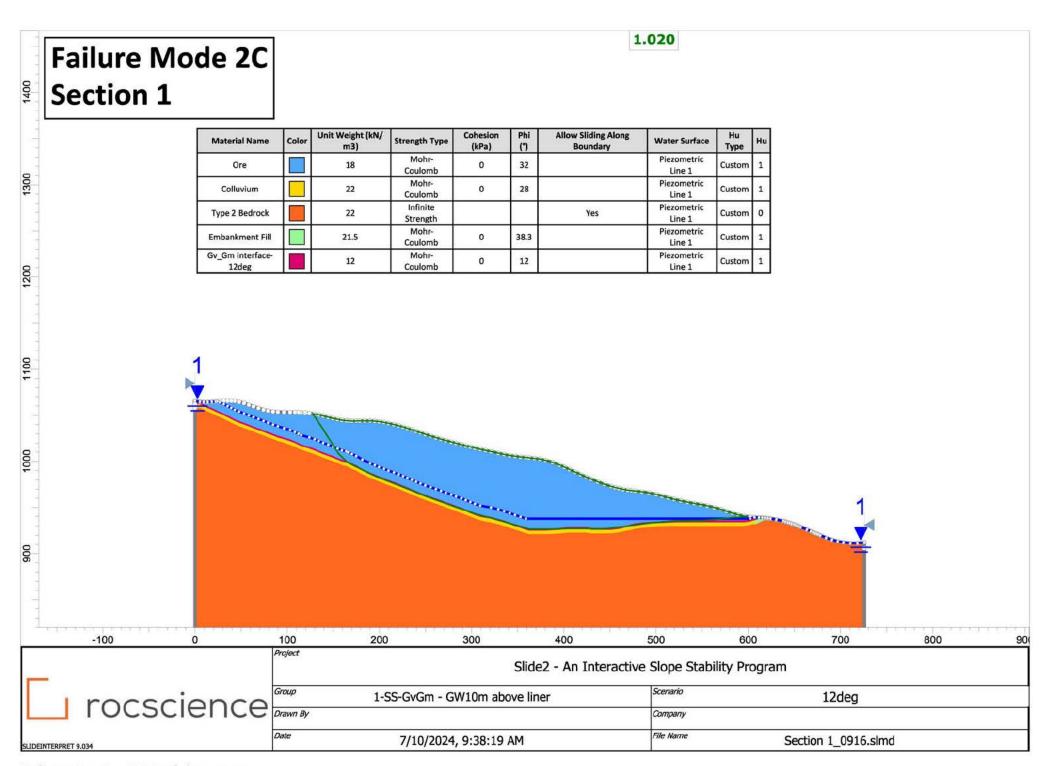
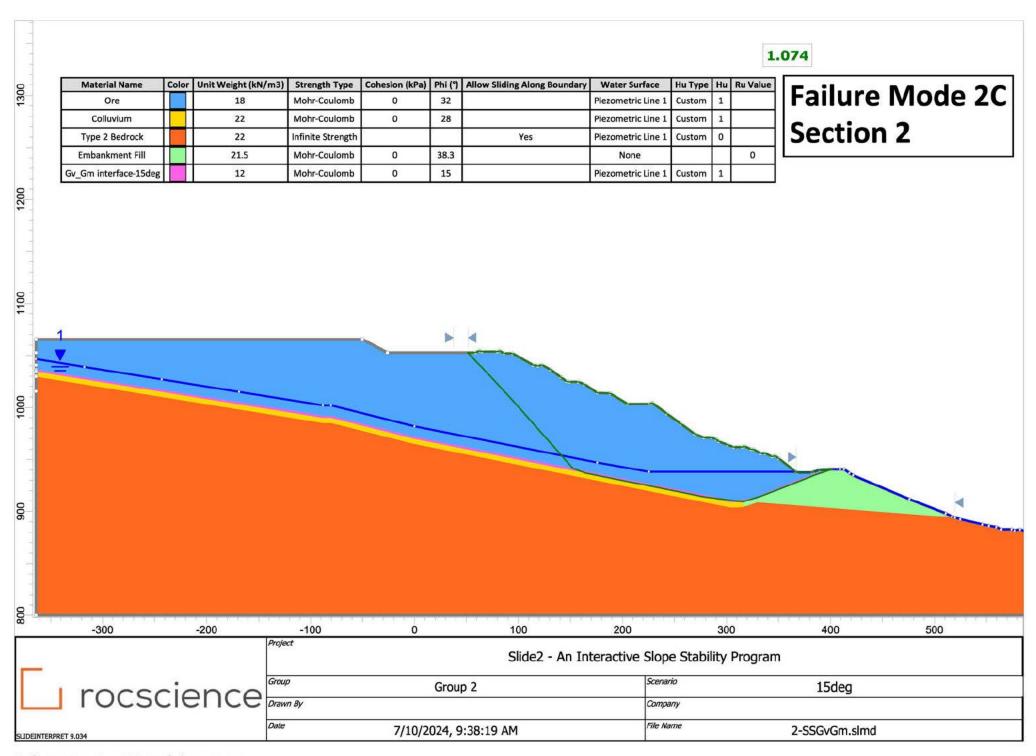
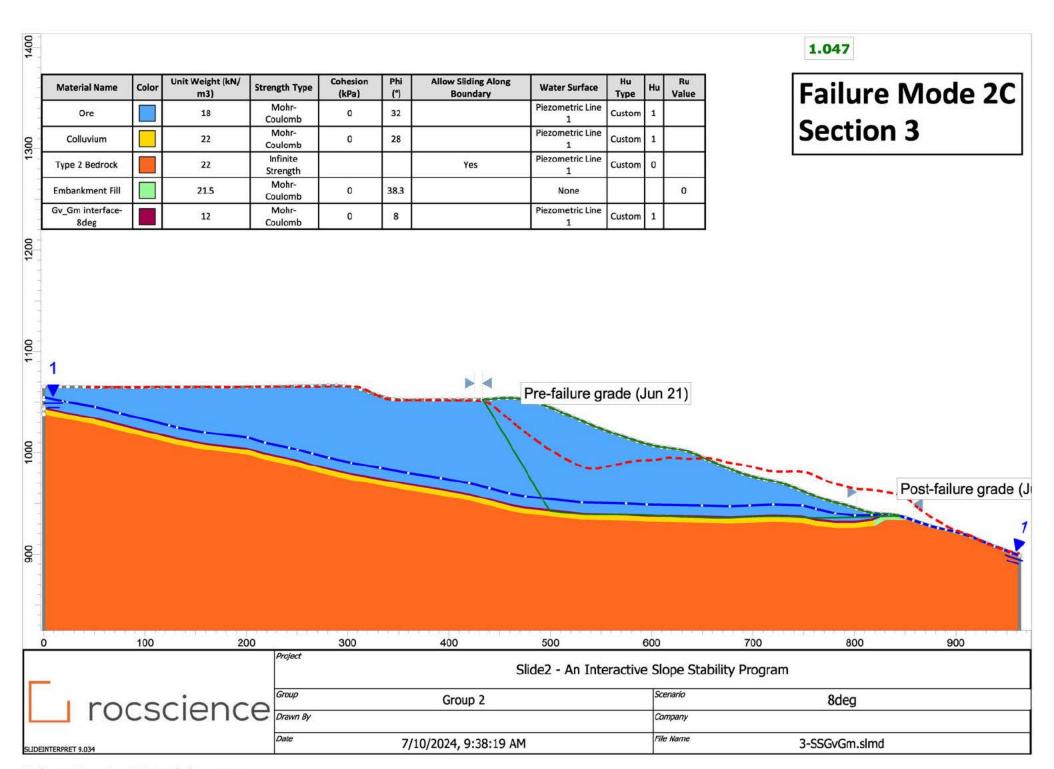
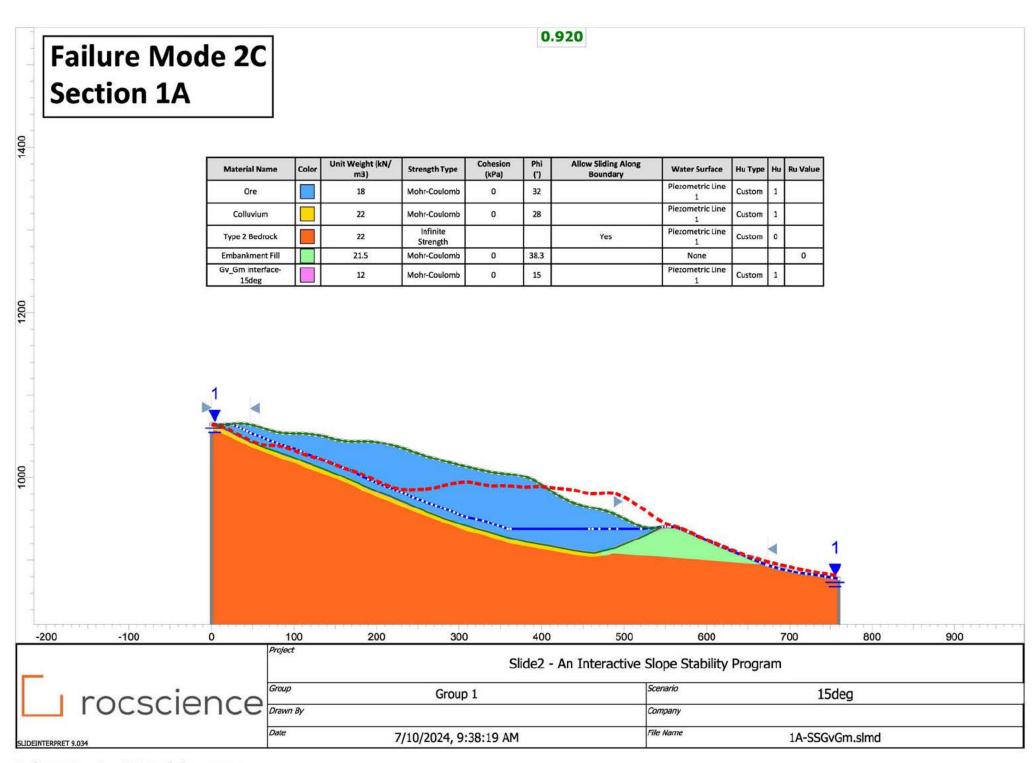
# Failure Mode 2C Lining failure along the interface between LLDPE Geomembrane and drainage gravel

Failure Mode \ Section	1	2	3	1A
Mode 2C – Lining failure along the interface between LLDPE Geomembrane and drainage gravel	Υ	Υ	Υ	Υ

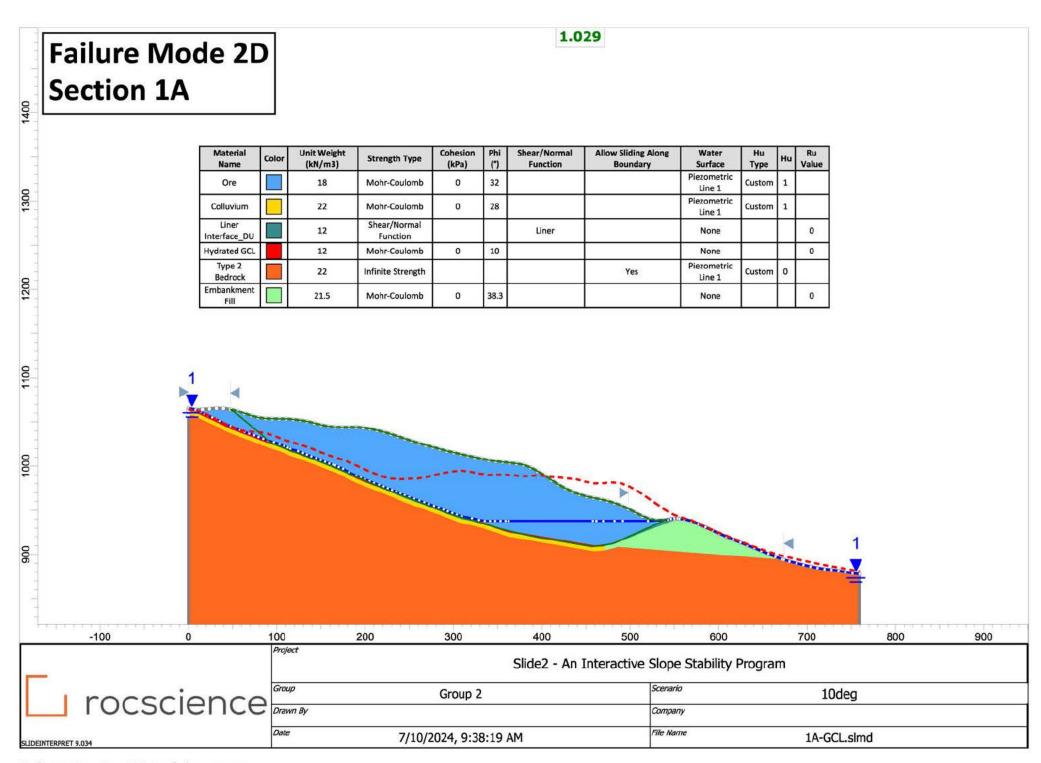
# Failure Mode 2D Lining instability due to slip failure within lining system (GCL)

Failure Mode \ Section	1	2	3	1A
Mode 2D - Lining instability due to slip failure within lining system (GCL)	N	N	N	Y
