# An Investigation into the causes of the Heap Leach Failure at Victoria Gold's Eagle Mine, Yukon

December 2024

Doc No.: 6408\_TR\_0\_Inv\_HLF\_Failure

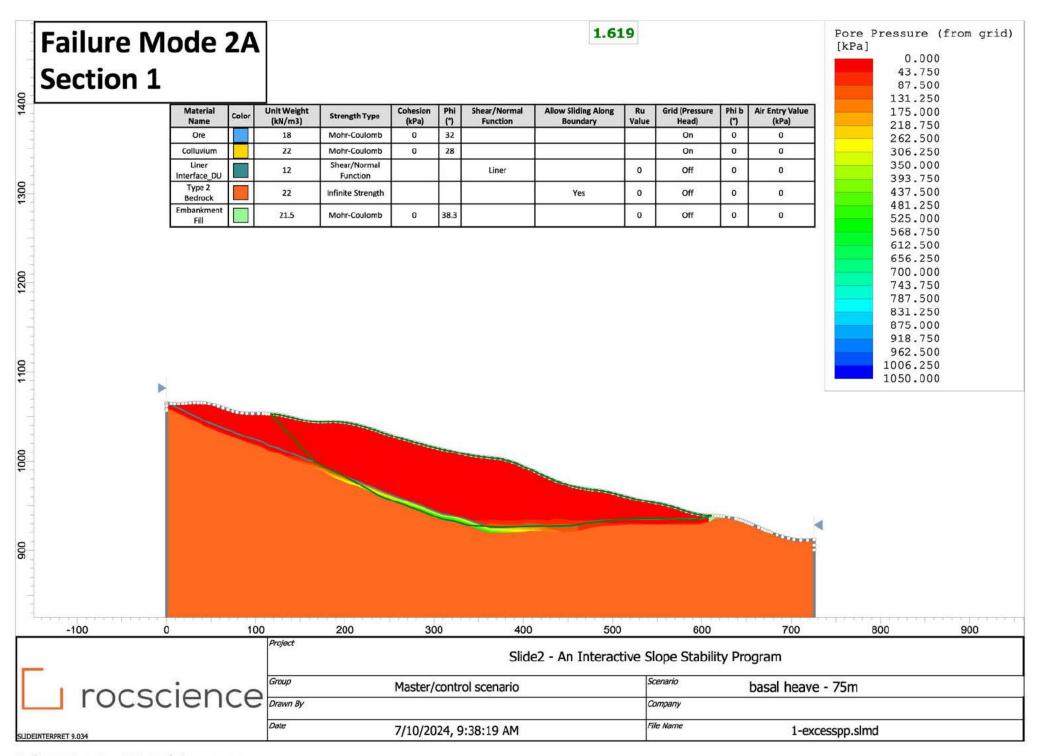
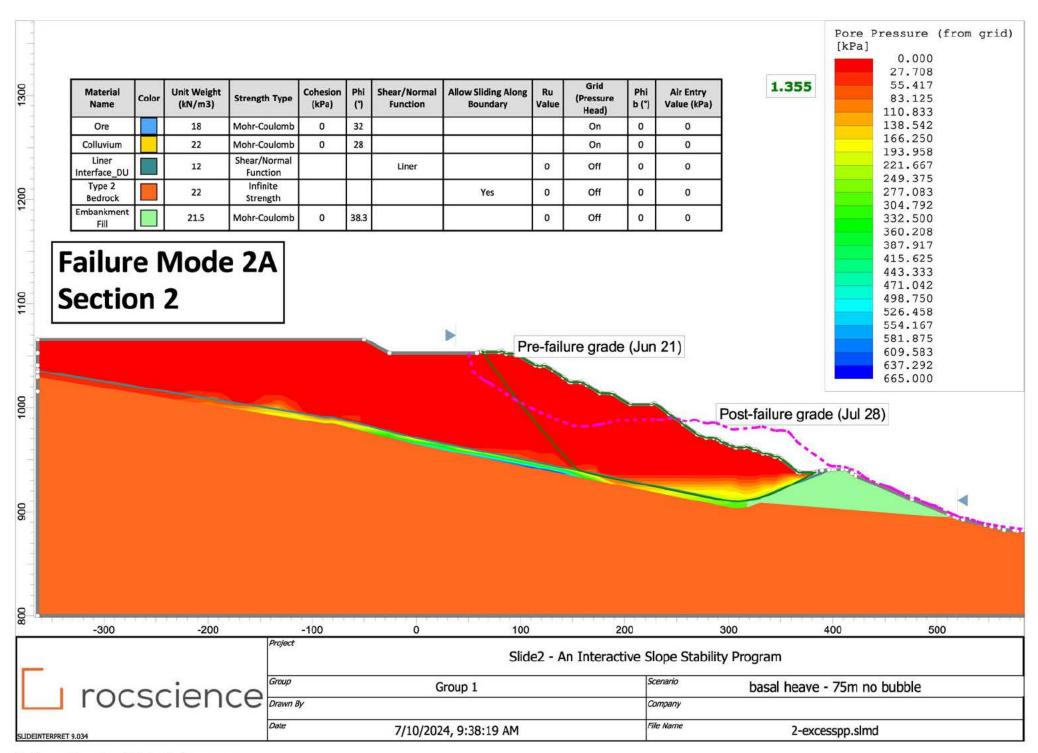
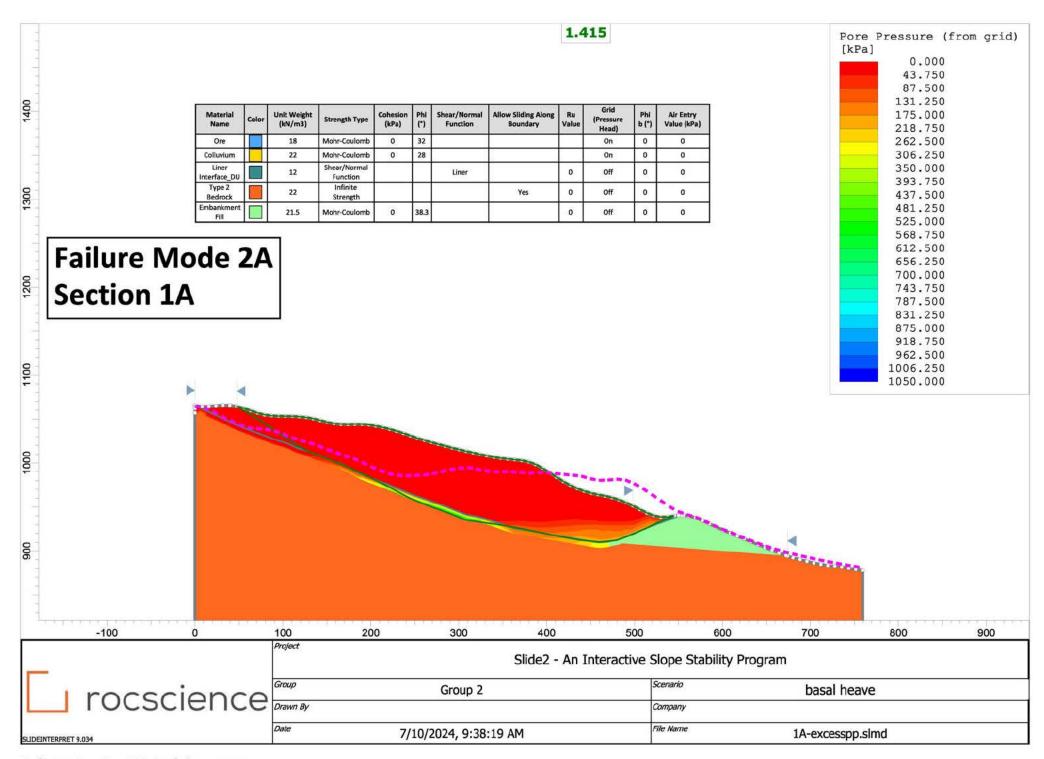
## Failure Mode 2A Lining instability due to hydraulic uplift (basal heave)

Failure Mode \ Section	1	2	3	1A
Mode 2A - Lining instability due to hydraulic uplift (basal heave)	Υ	Y	N	Y

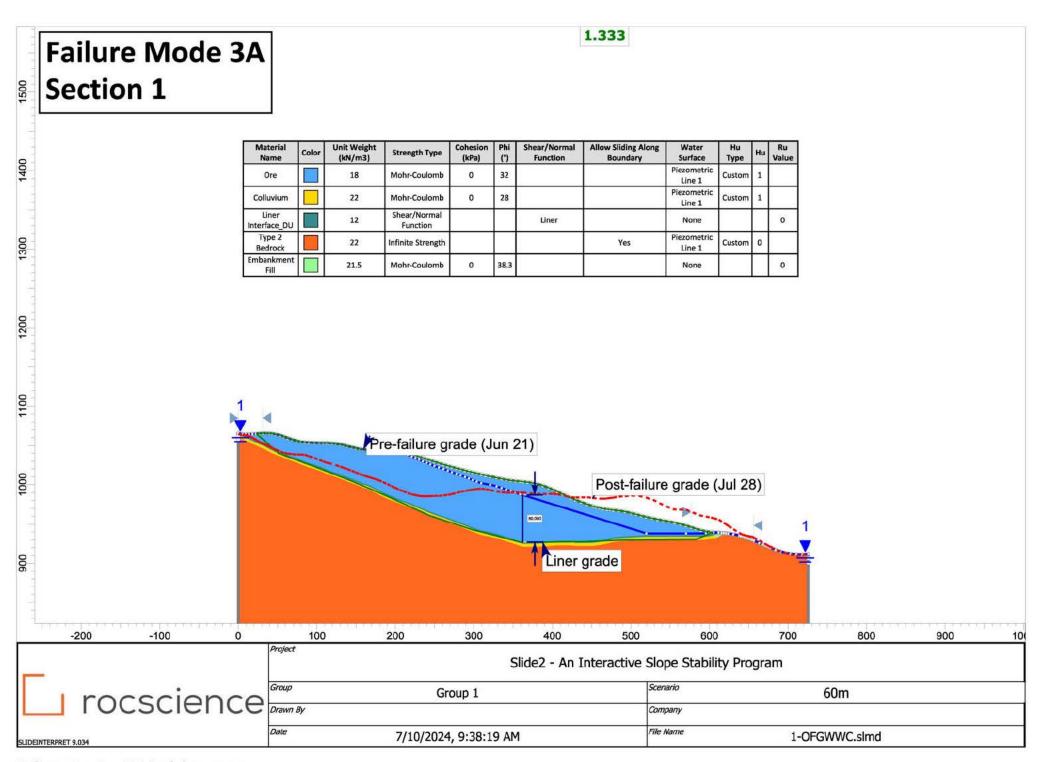
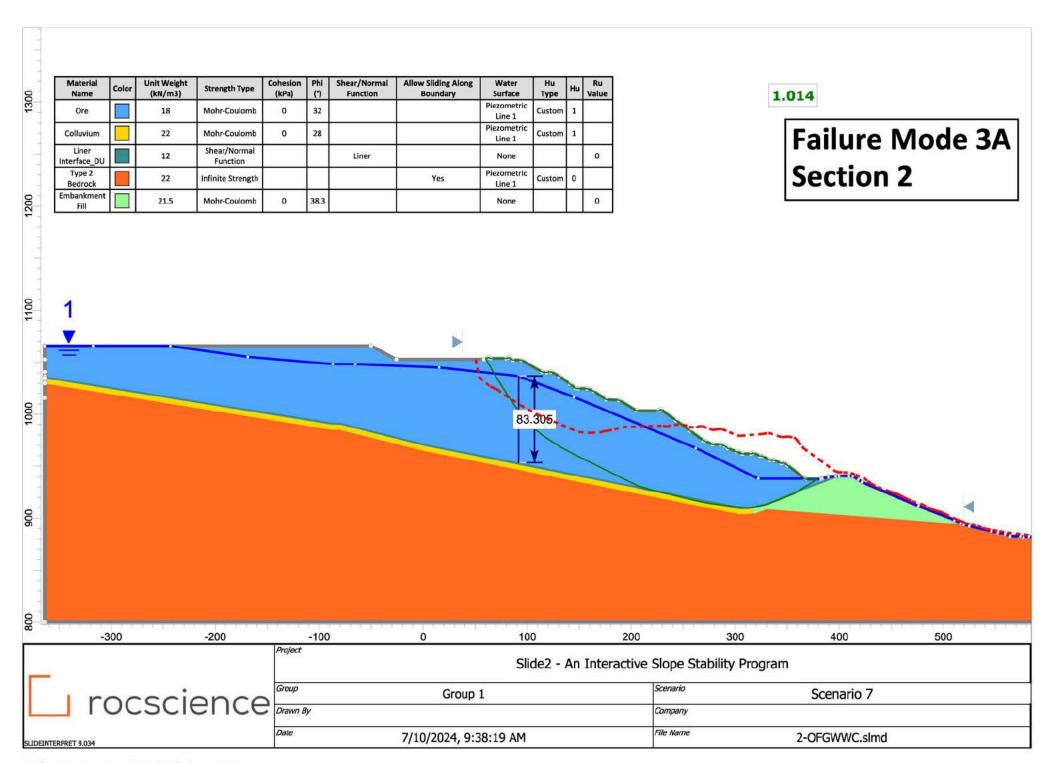
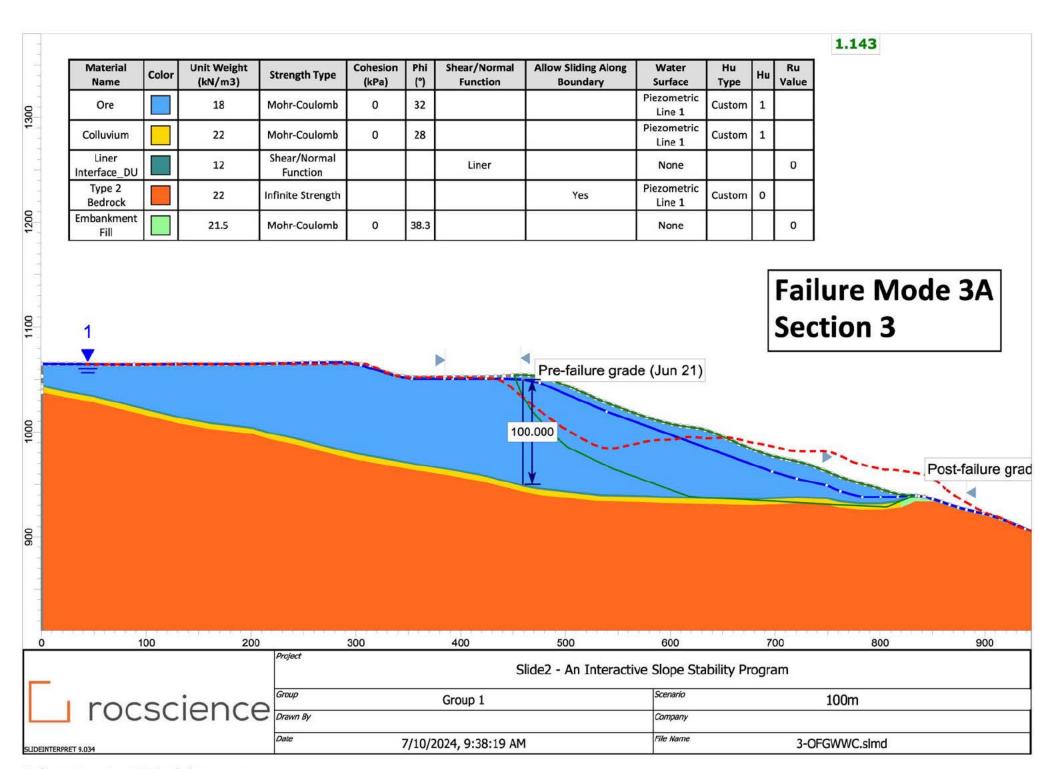
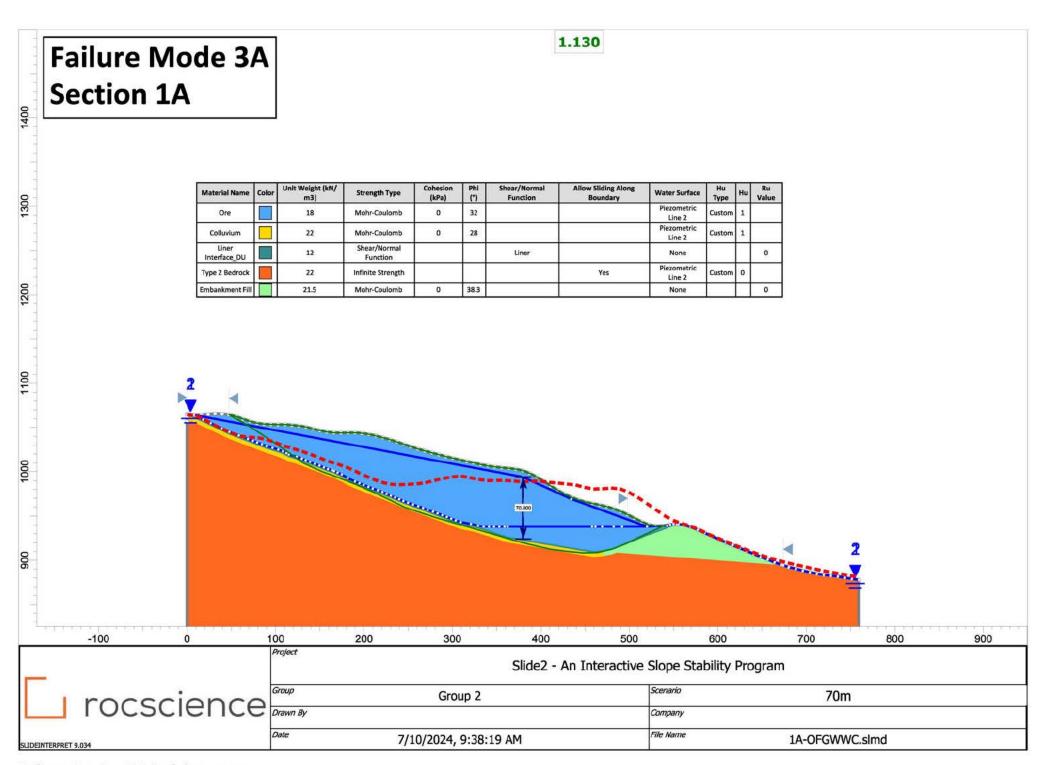
## Failure Mode 3A Ore failure due to increased piezometric level

Failure Mode \ Section	1	2	3	1A
Mode 3A – Ore failure due to increased piezometric level	Υ	Υ	Υ	Υ

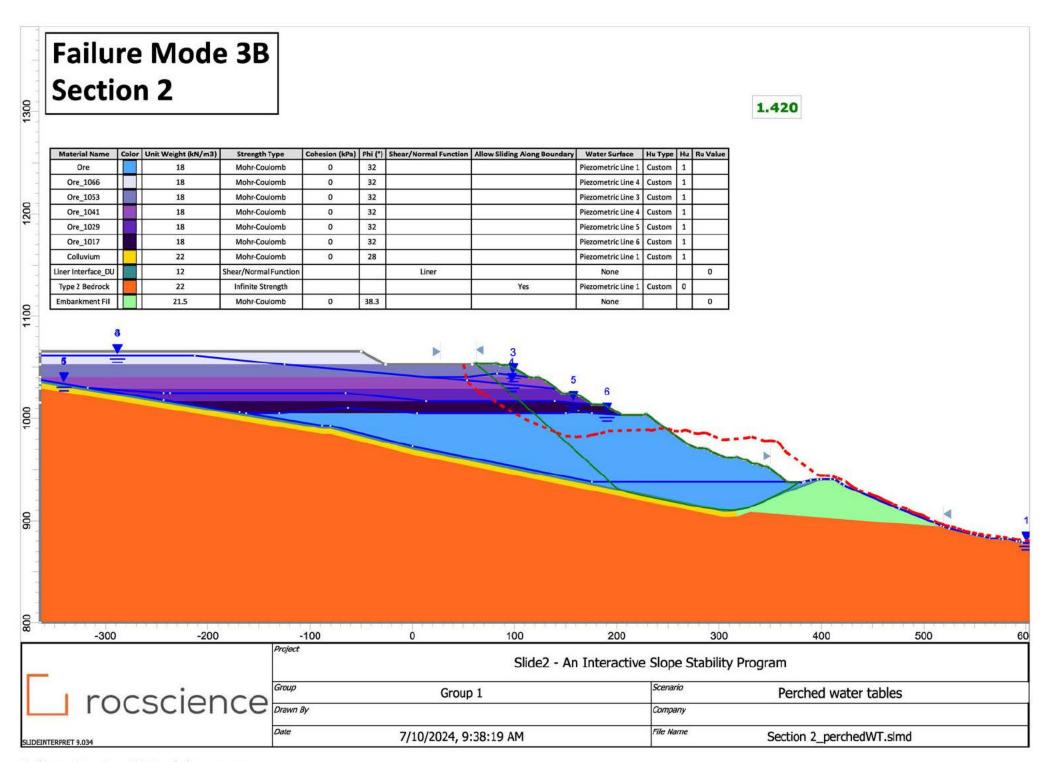
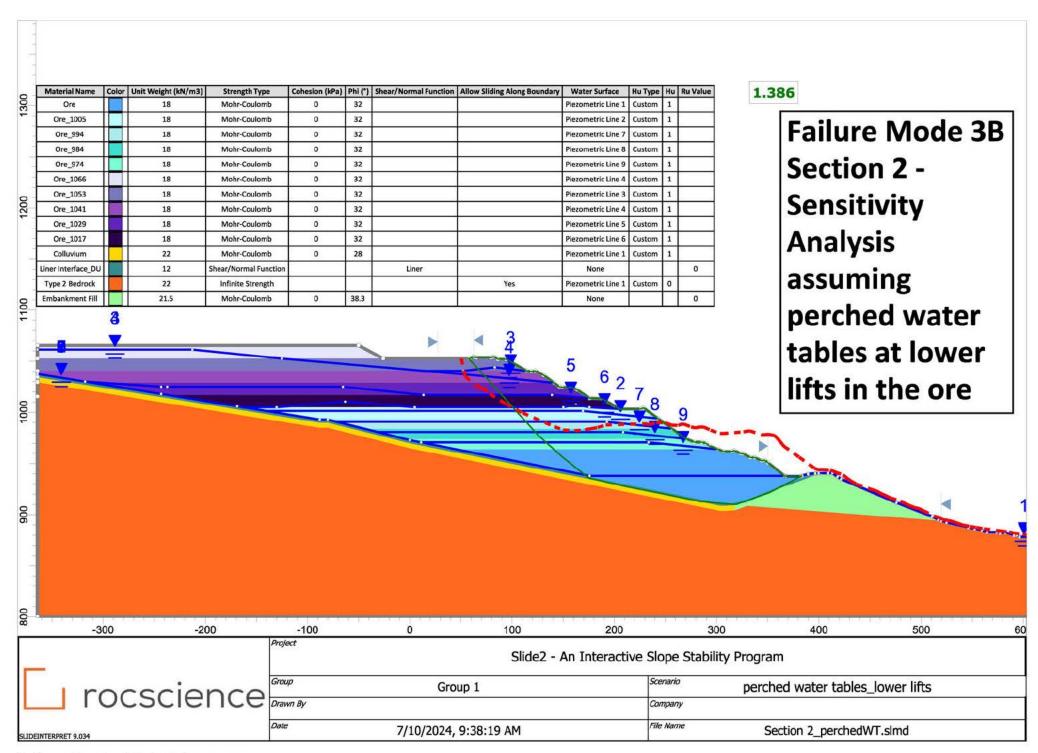
### Failure Mode 3B Ore failure due to perched water tables

Failure Mode \ Section	1	2	3	1A
Mode 3B – Ore failure due to perched water tables	N	Y	N	N

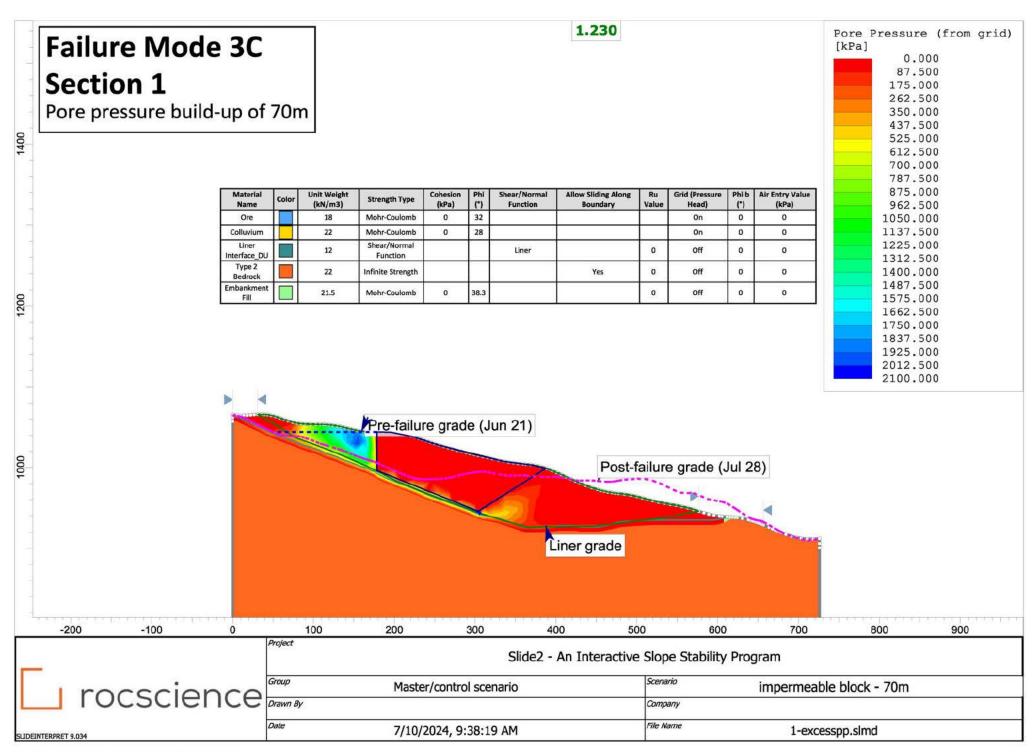
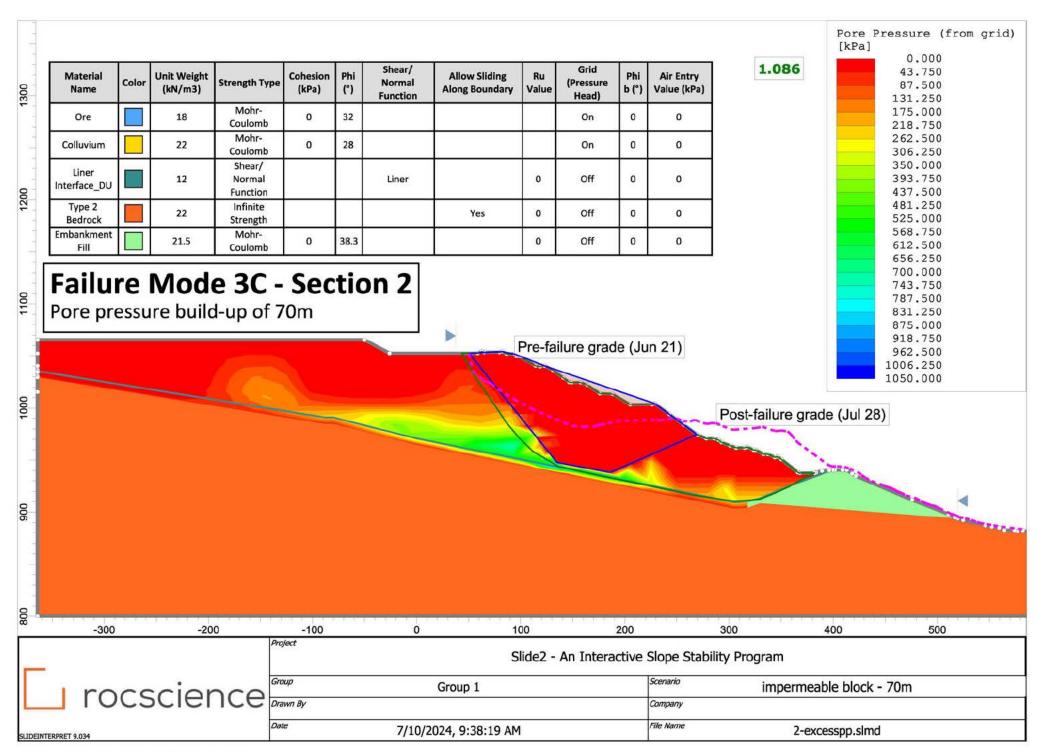
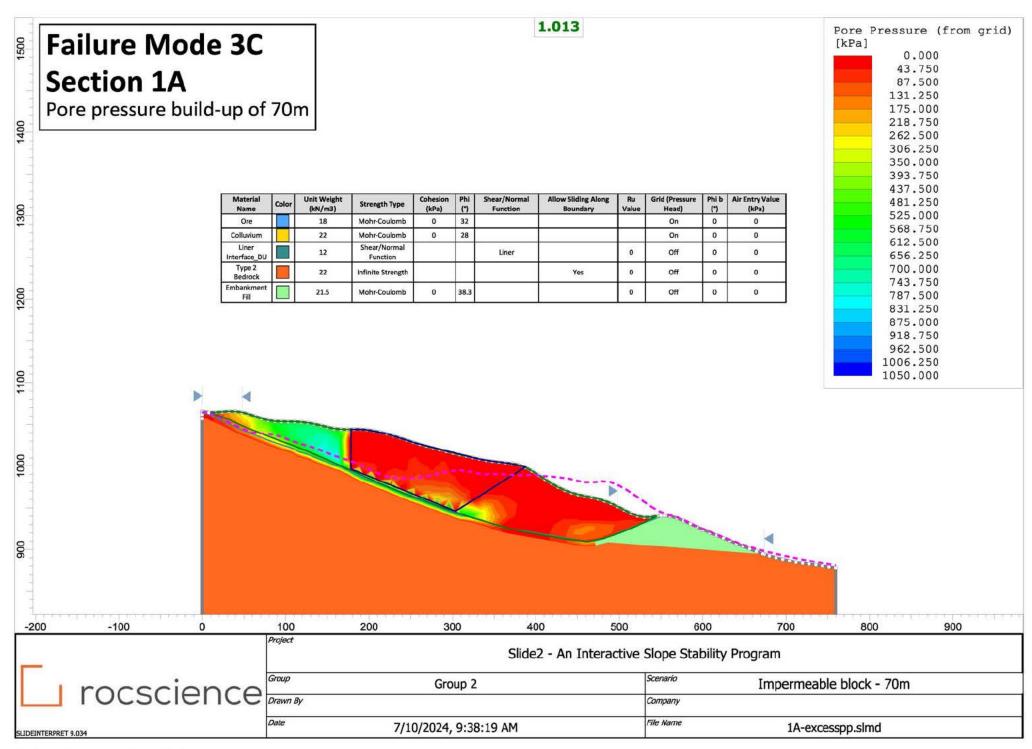
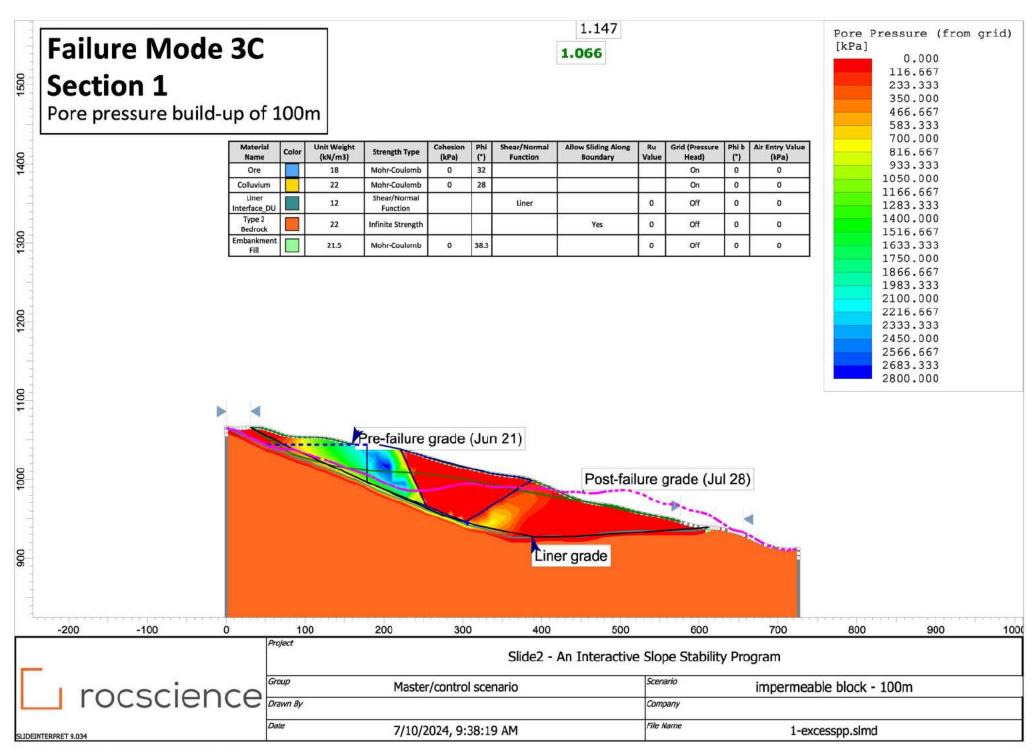
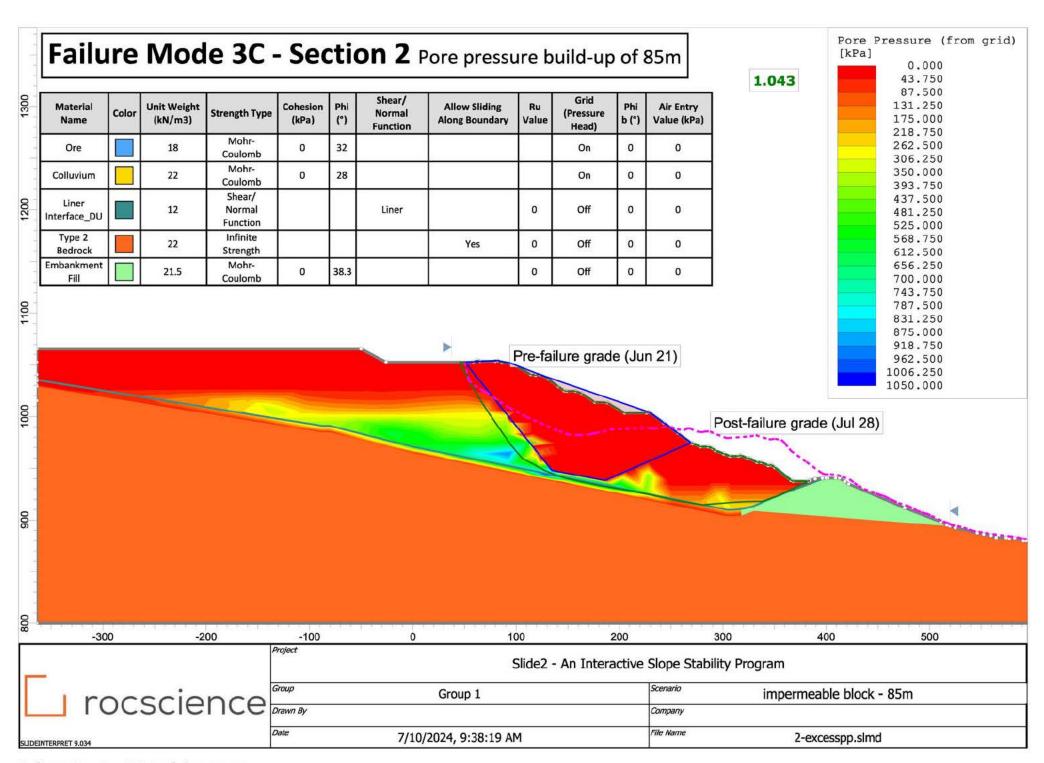
### Failure Mode 3C Ore failure due to hydrostatic uplift pressures

Failure Mode \ Section	1	2	3	1A
Mode 3C - Ore failure due to hydrostatic uplift pressures	Υ	Υ	N	Y
